THE MAIN CAUSES OF FUEL ELEMENT FAILURE IN WATER-COOLED POWER REACTORS

F. GARZAROLLI, R. von JAN, H. STEHLE
Kraftwerk Union Aktiengesellschaft,
Erlangen,
Federal Republic of Germany

ABSTRACT. The fuel failures observed in water-cooled power reactors (PWR, BWR, HWR) are classified according to the underlying mechanisms, i.e. hydriding, pellet-clad interaction (PCI), corrosion, clad collapsing, Zircaloy growth, rod and assembly bowing and fretting wear. The historical development of fuel designs and failure rates is briefly reviewed. Over the last decade the average fuel rod failure rate has dropped to near 0.02% and the majority of failures are at present caused by particular incidences. The present technological understanding of these failure types and their interpretation are presented in more detail. Hydriding, clad collapsing, unanticipated growth and fretting have mainly been caused by inadequate design or manufacturing in the early days and should not be a problem in future. PCI, external corrosion at high burnup and rod and assembly bowing are more generic mechanisms and need further consideration. Experience from the continued operation of defective fuel rods has confirmed

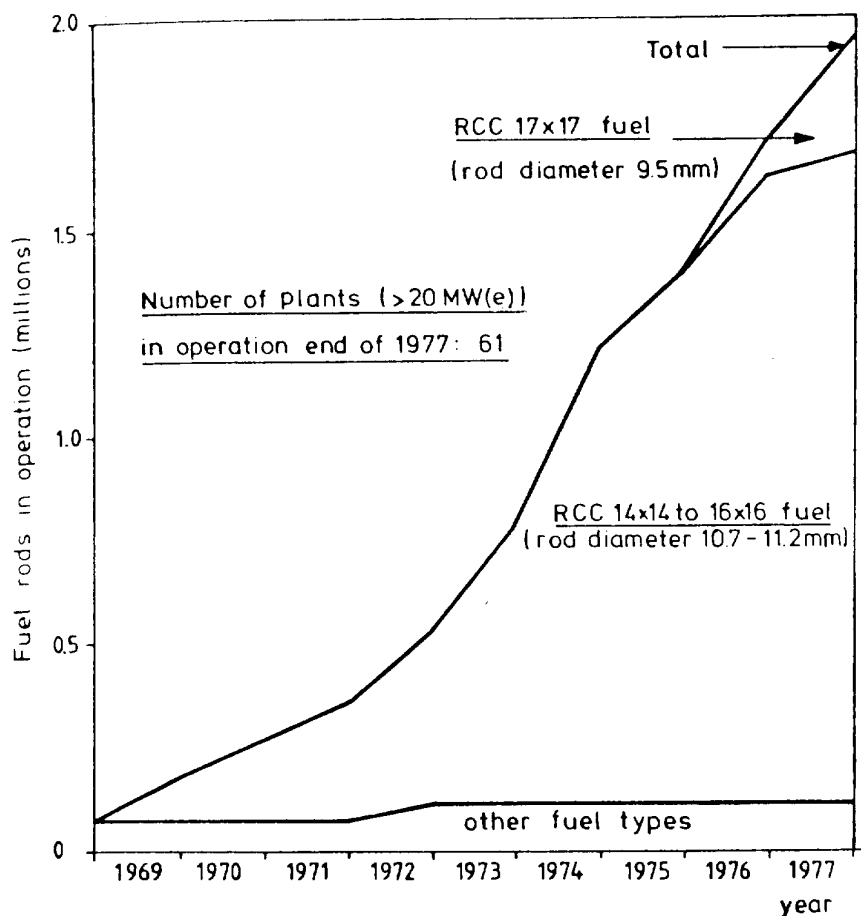
FIG. 3. Number of PWR fuel rods in operation.

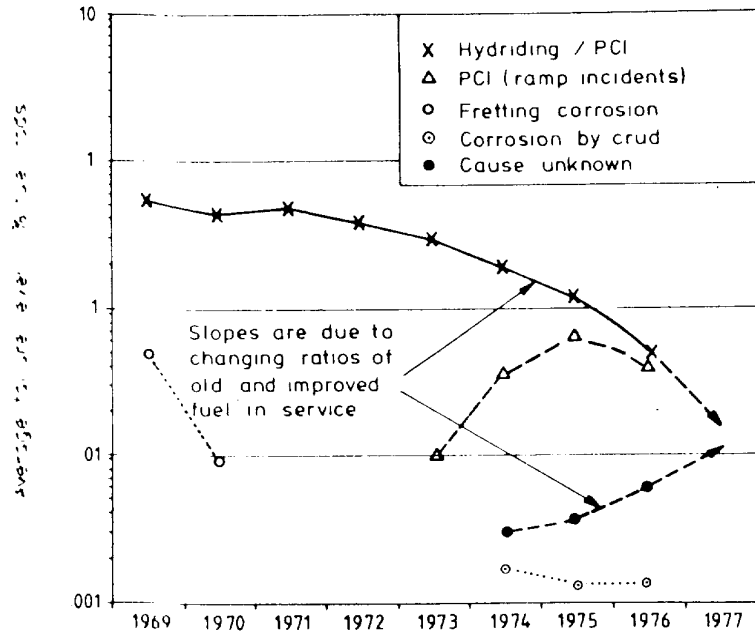
FIG.11. Overall significance of fuel failures in BWR plants.

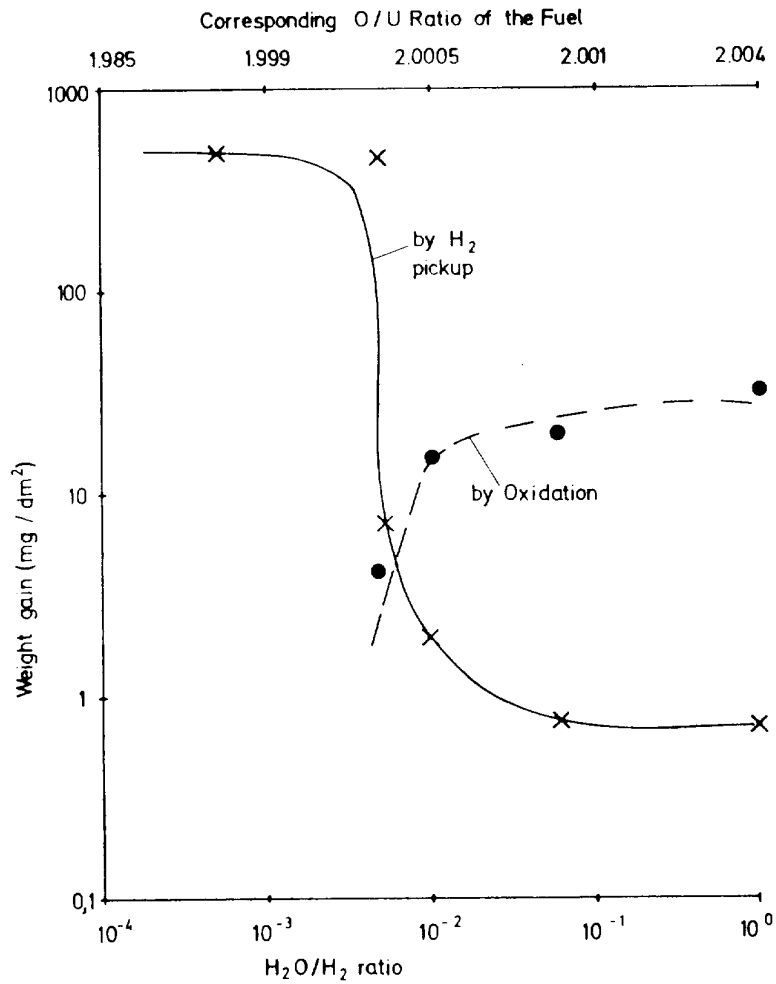
FIG. 18. Influence of the H₂O/H₂ ratio on oxidation and hydriding of Zircaloy in 10 mbar H₂O-H₂ mixtures at 400°C after 8 hours [31].

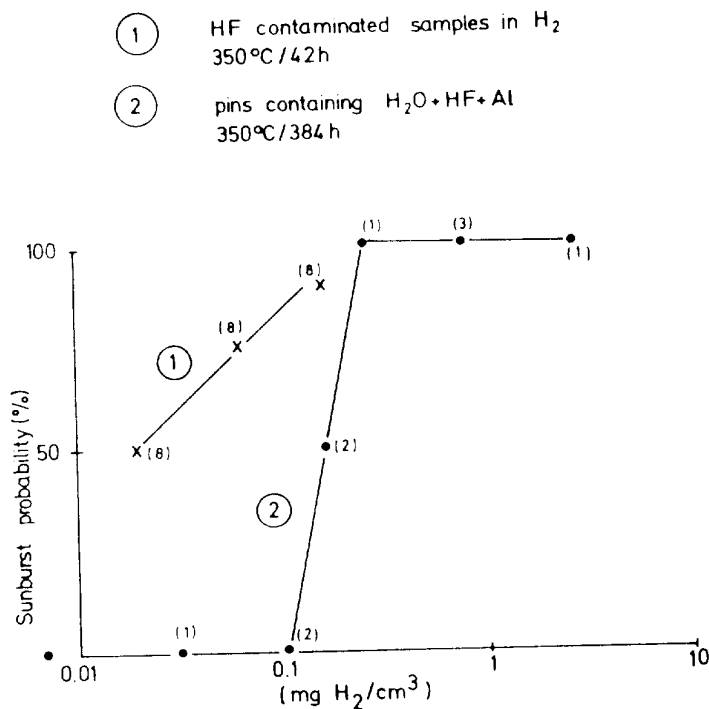
FIG.19. Influence of the total hydrogen concentration on the out-of-reactor probabilities of sunburst formation in hydrofluoric acid-contaminated Zircaloy samples at 350°C under wet hydrogen in a water environment.

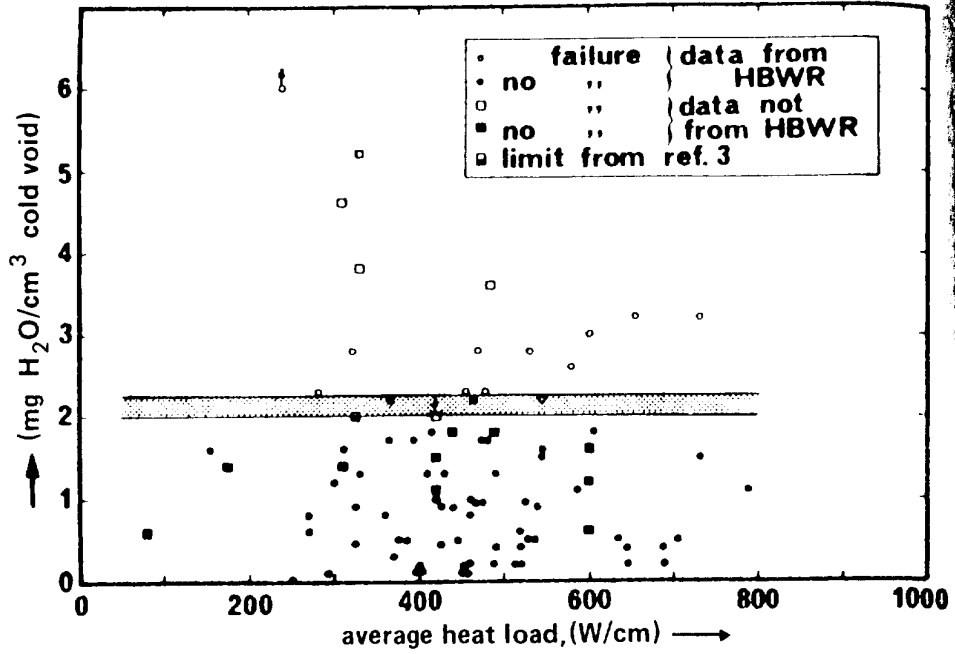
FIG.20. Primary hydride defects in relation to initial gas phase moisture equivalent and linear heat generation rate [36].

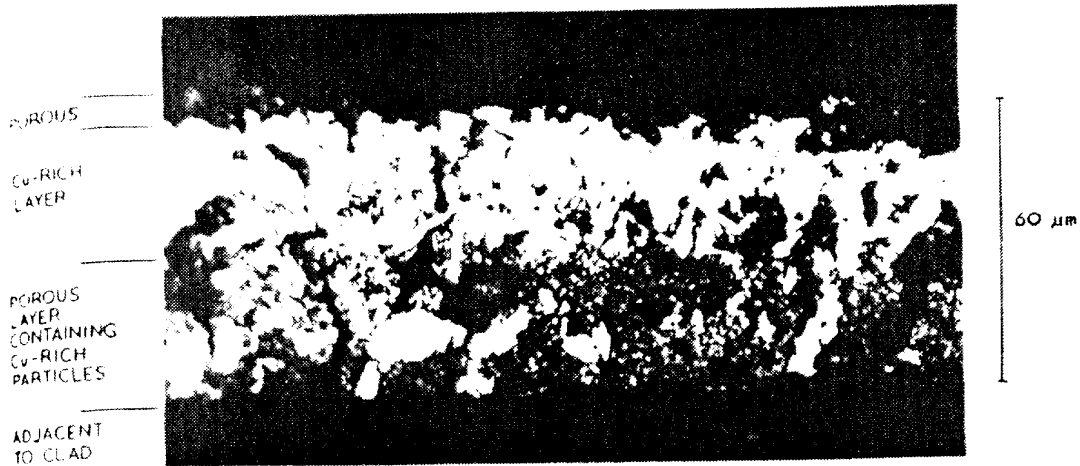
FIG.22. Types of crud layer on fuel rods [41]: (a) dense crud; (b) porous crud.

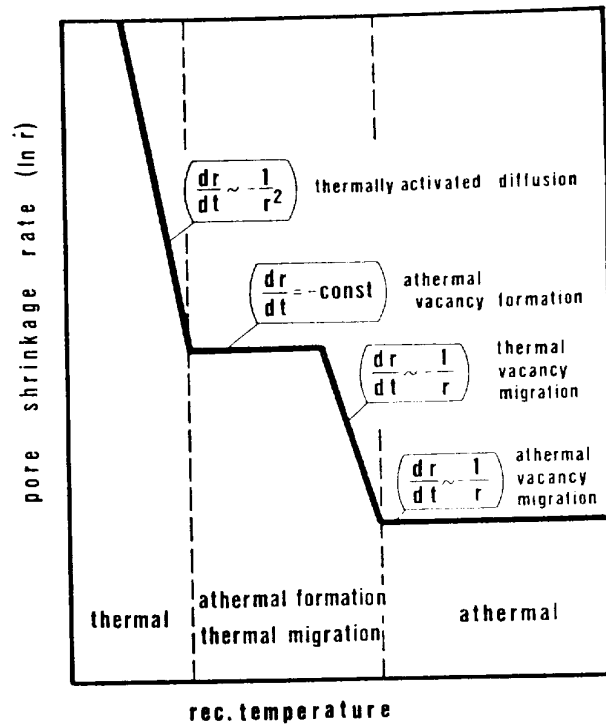
FIG.44. Arrhenius plot for the pore shrinkage rate [90].
