# **Microstructural Modification of 2-1/4 Cr-1 Mo Steel by Irradiation with 14 MeV Nickel Ions**

**UWFDM-667**

Presented at the 1985 TMS-AIME Fall Meeting, 13-17 October 1985, Toronto, Ontario.

***FUSION TECHNOLOGY INSTITUTE  
UNIVERSITY OF WISCONSIN  
MADISON WISCONSIN***

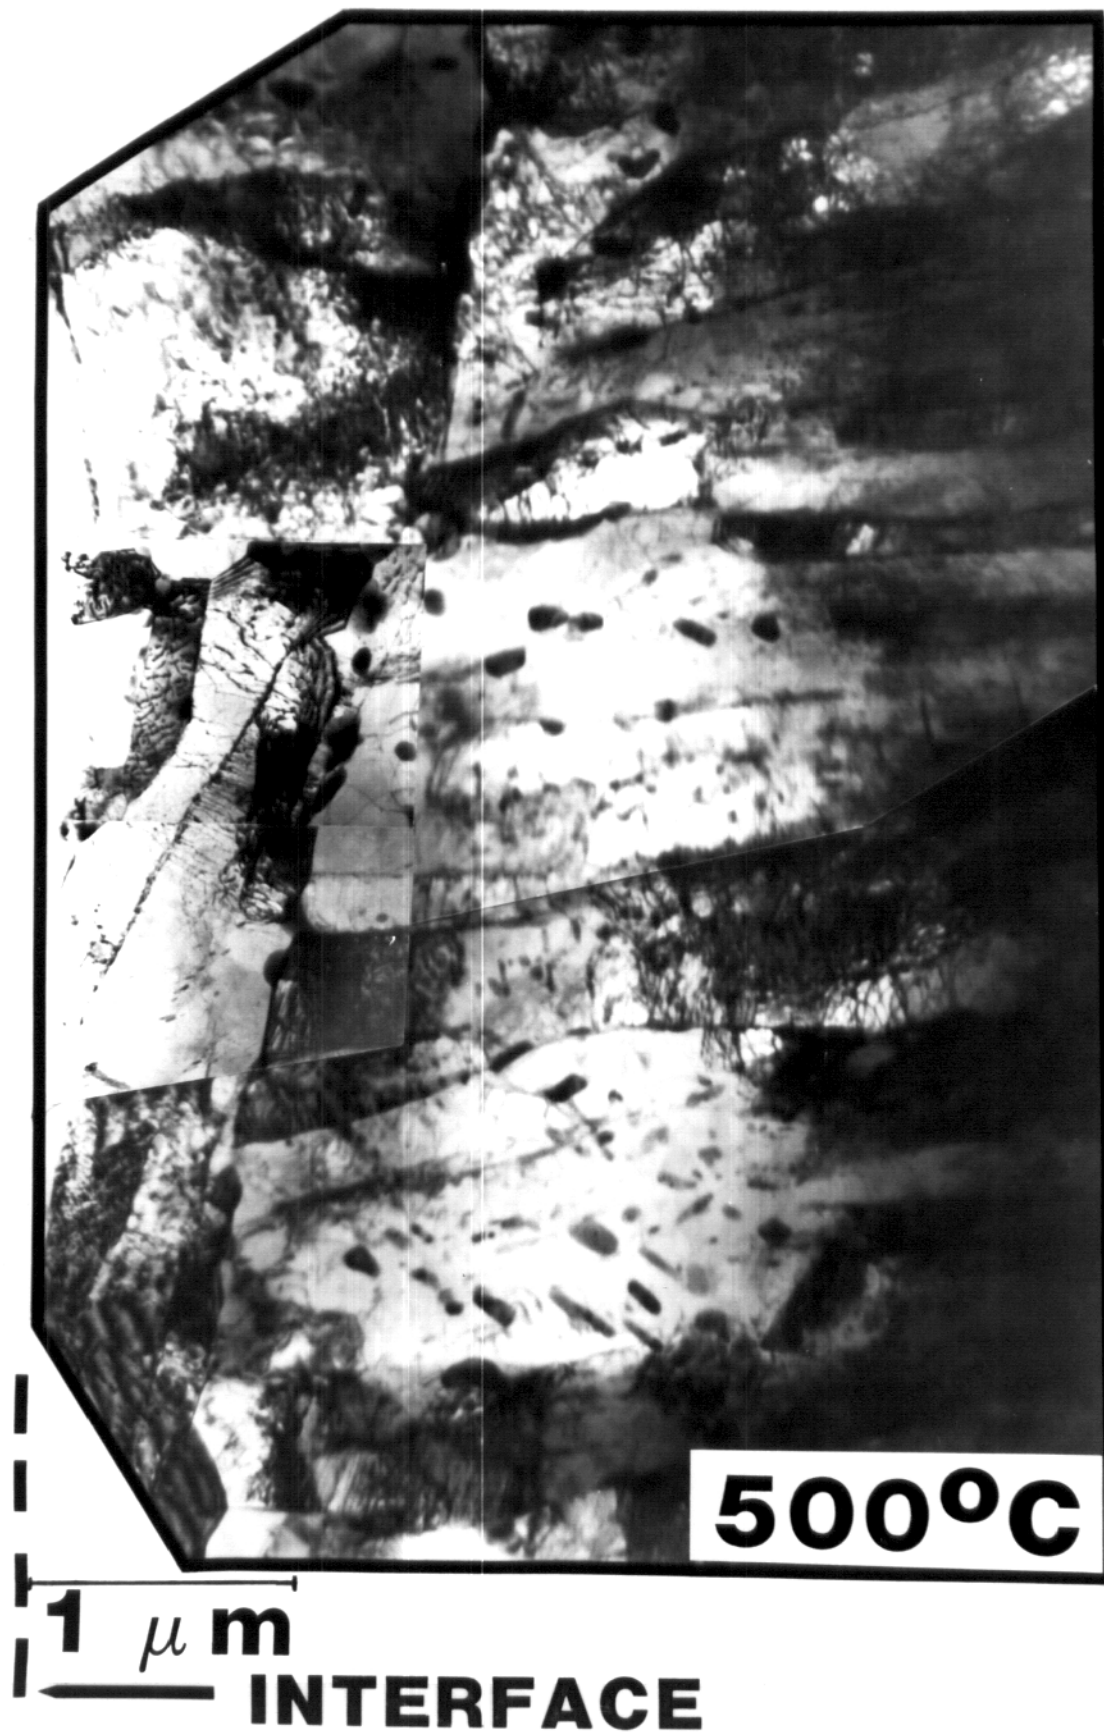
FIGURE 3

- Fig. 3. Transmission electron micrographs spanning the entire damage region of 14 MeV Ni-ion irradiated 2 1/4 Cr-1 Mo which initially contained upper bainite. Note the drastic restructuring of the upper bainite throughout the entire 3  $\mu\text{m}$  range of damage.

**14 MeV Ni-ION-IRRADIATED 2 1/4Cr 1Mo  
THROUGH-RANGE MICROSTRUCTURE**

Figure 3 shows a thin foil TEM micrograph which spans the entire damage range of a region of the 2 1/4 Cr-1 Mo steel which initially contained upper bainite. It can be seen that extensive restructuring of the upper bainite has occurred to a depth of  $\sim 3 \mu\text{m}$  from the surface of the irradiated sample. This corresponds well to the calculated damage range shown in Fig. 1. Figure 4 shows an enlarged view of this irradiated microstructure at the 1  $\mu\text{m}$  depth (80 dpa), the 2.1  $\mu\text{m}$  depth (350 dpa) and the thermal control region of the upper bainite ( $> 3 \mu\text{m}$  depth). The irradiation has nearly eliminated the lath structure of the upper bainite. In addition, the prior lath boundary  $\text{Fe}_3\text{C}$  has disappeared, and  $\text{M}_2\text{C}$ ,  $\text{M}_7\text{C}_3$ , and  $\chi$  phases were produced and identified from low-order zone diffraction patterns [8]. Their chemical analyses, obtained from

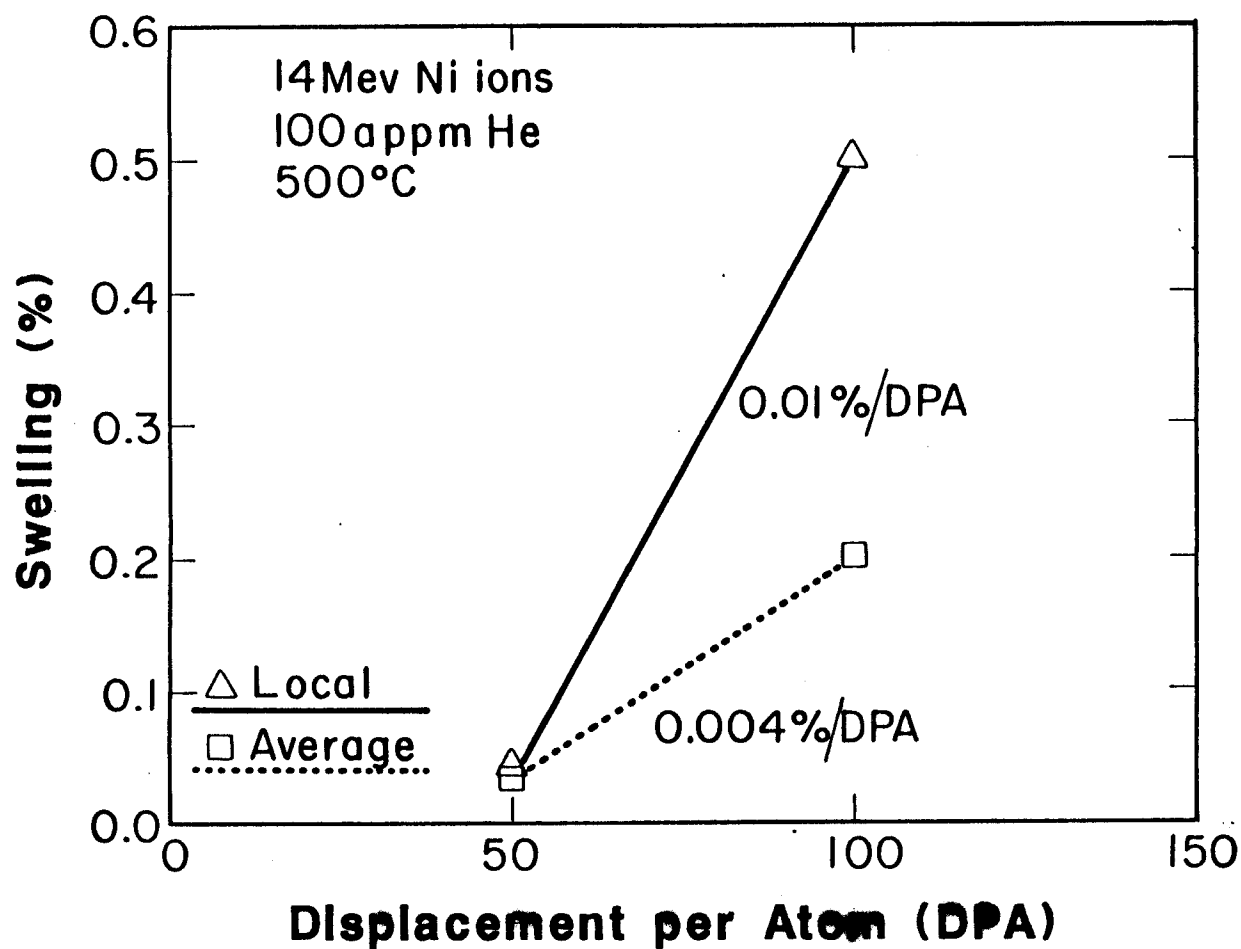
FIGURE 11

## Swelling vs. DPA in Fe-2 1/4 Cr-1 Mo

Figure 11 shows the average swelling rate determined in this study which suggests that the bulk-averaged rate of swelling is less than 0.01%/dpa. However, the local swelling rate is  $> 0.01\%/dpa$ . It is still noted, however, that the dose level (100 dpa) is probably not sufficient to establish the steady state [17] swelling rate.
