Progress Report:

Effect of Helium and Deuterium Implantation on Tungsten Surfaces at $T > 1000$ °C

HAPL Workshop
September 24-25, 2003

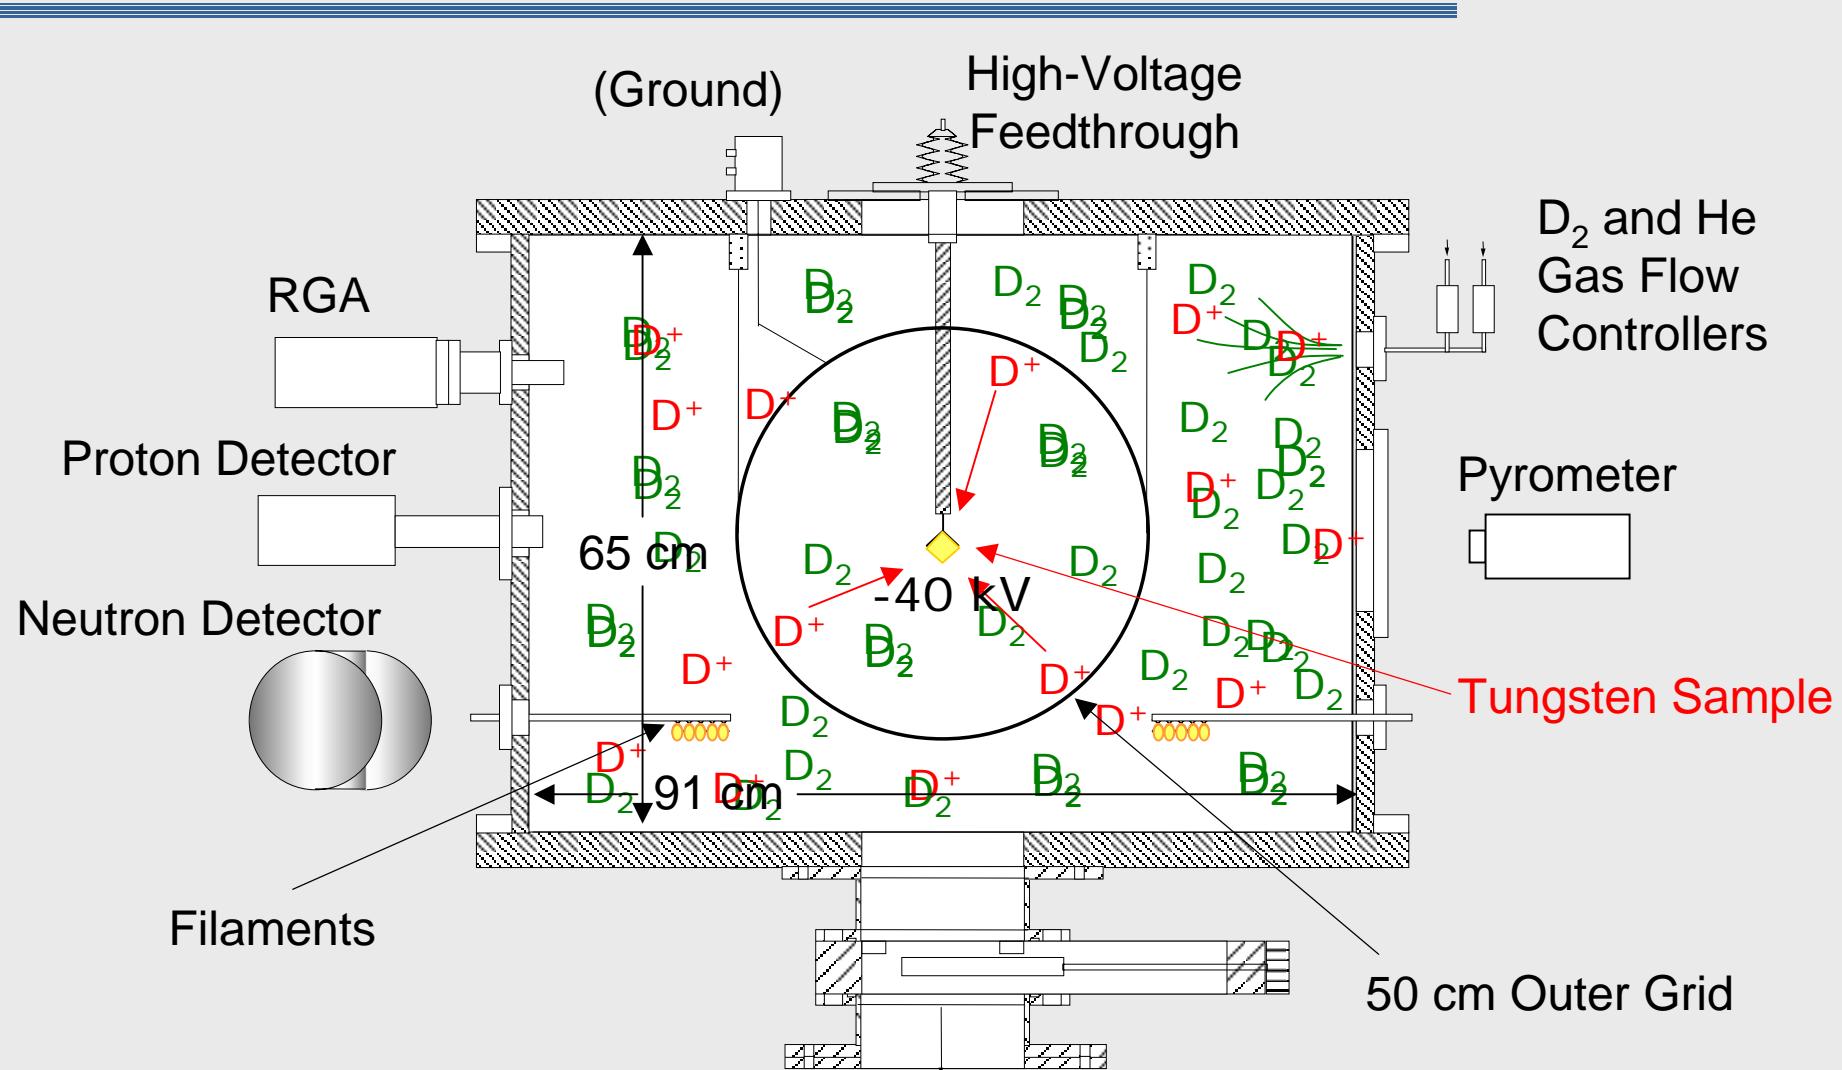
IEC Chamber Used for Ion Implantation

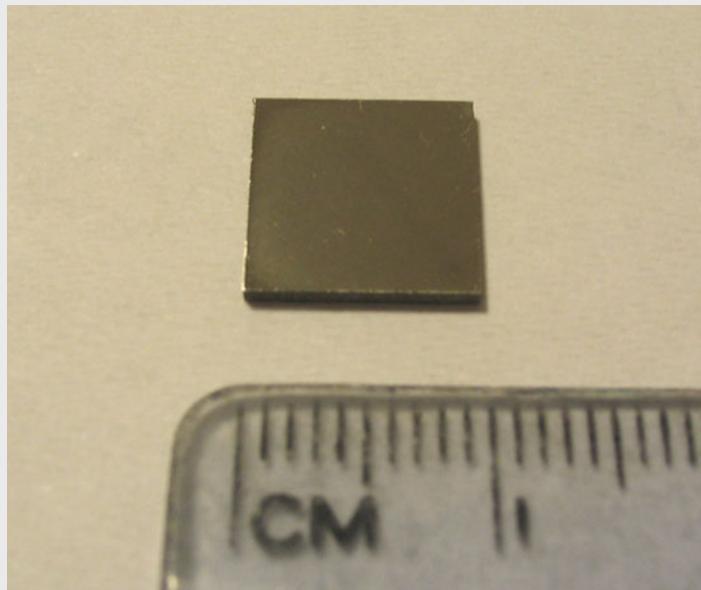
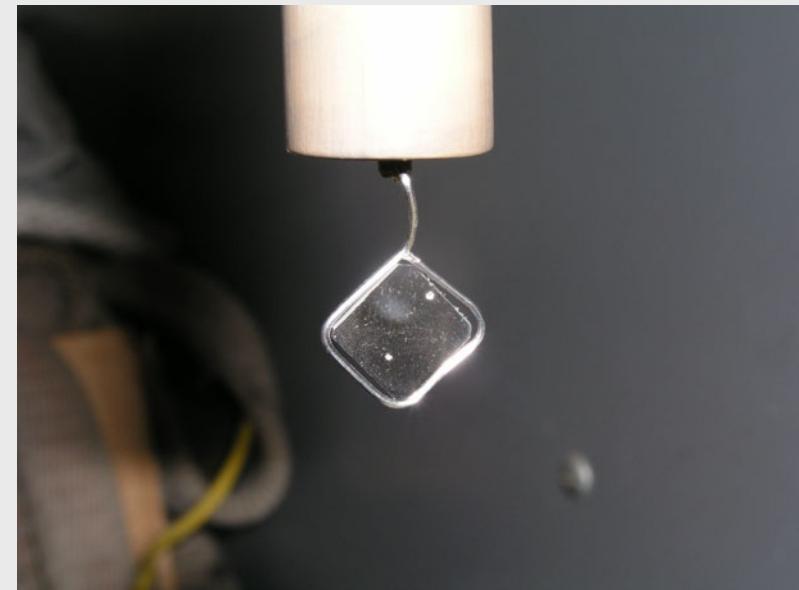
Tungsten Samples

- Powder metallurgy samples
- Obtained from Lance Snead, Oak Ridge
- Polished finish
- Lot #F05M12, stock #13981
- Spot-welded on to a W-Re wire loop

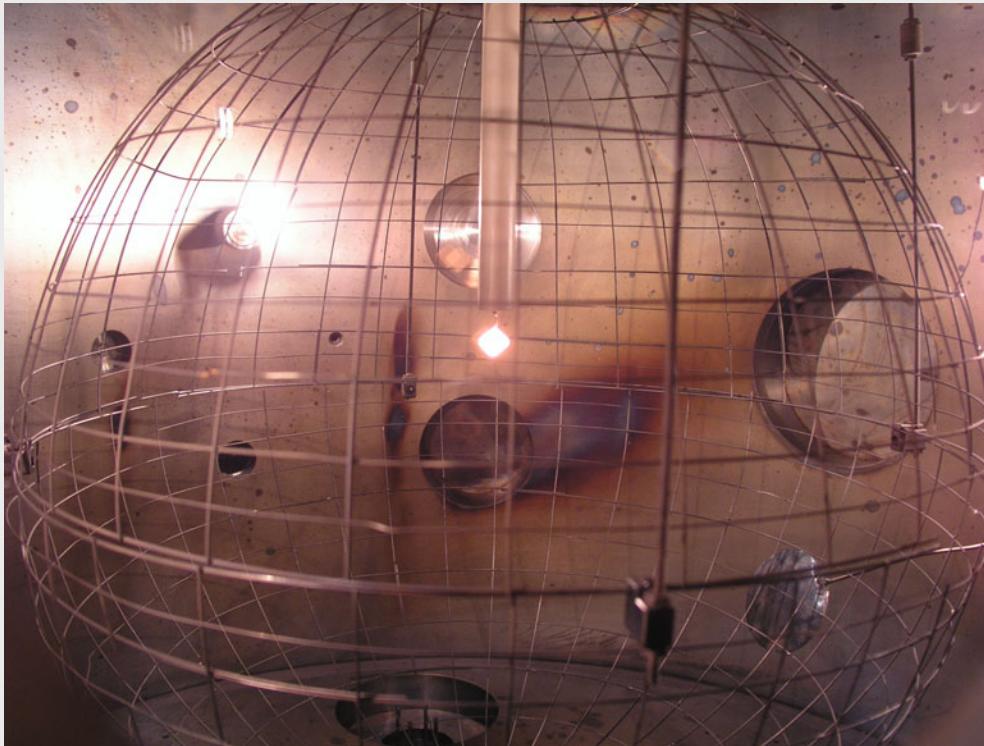
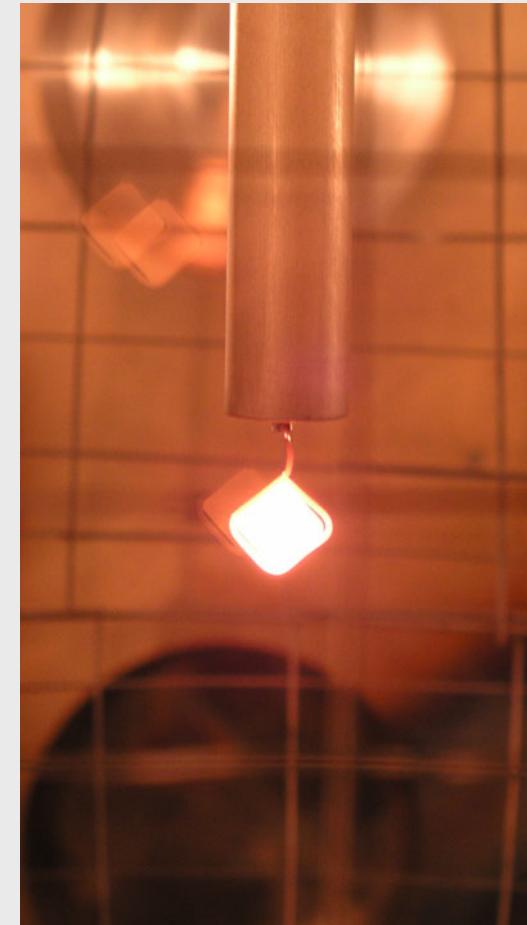
UW IEC Chamber has Capability of High-Temperature Implantation at 10-150 kV

D⁺, 20 kV, 5 mA
2 mtorr, 1100 °C

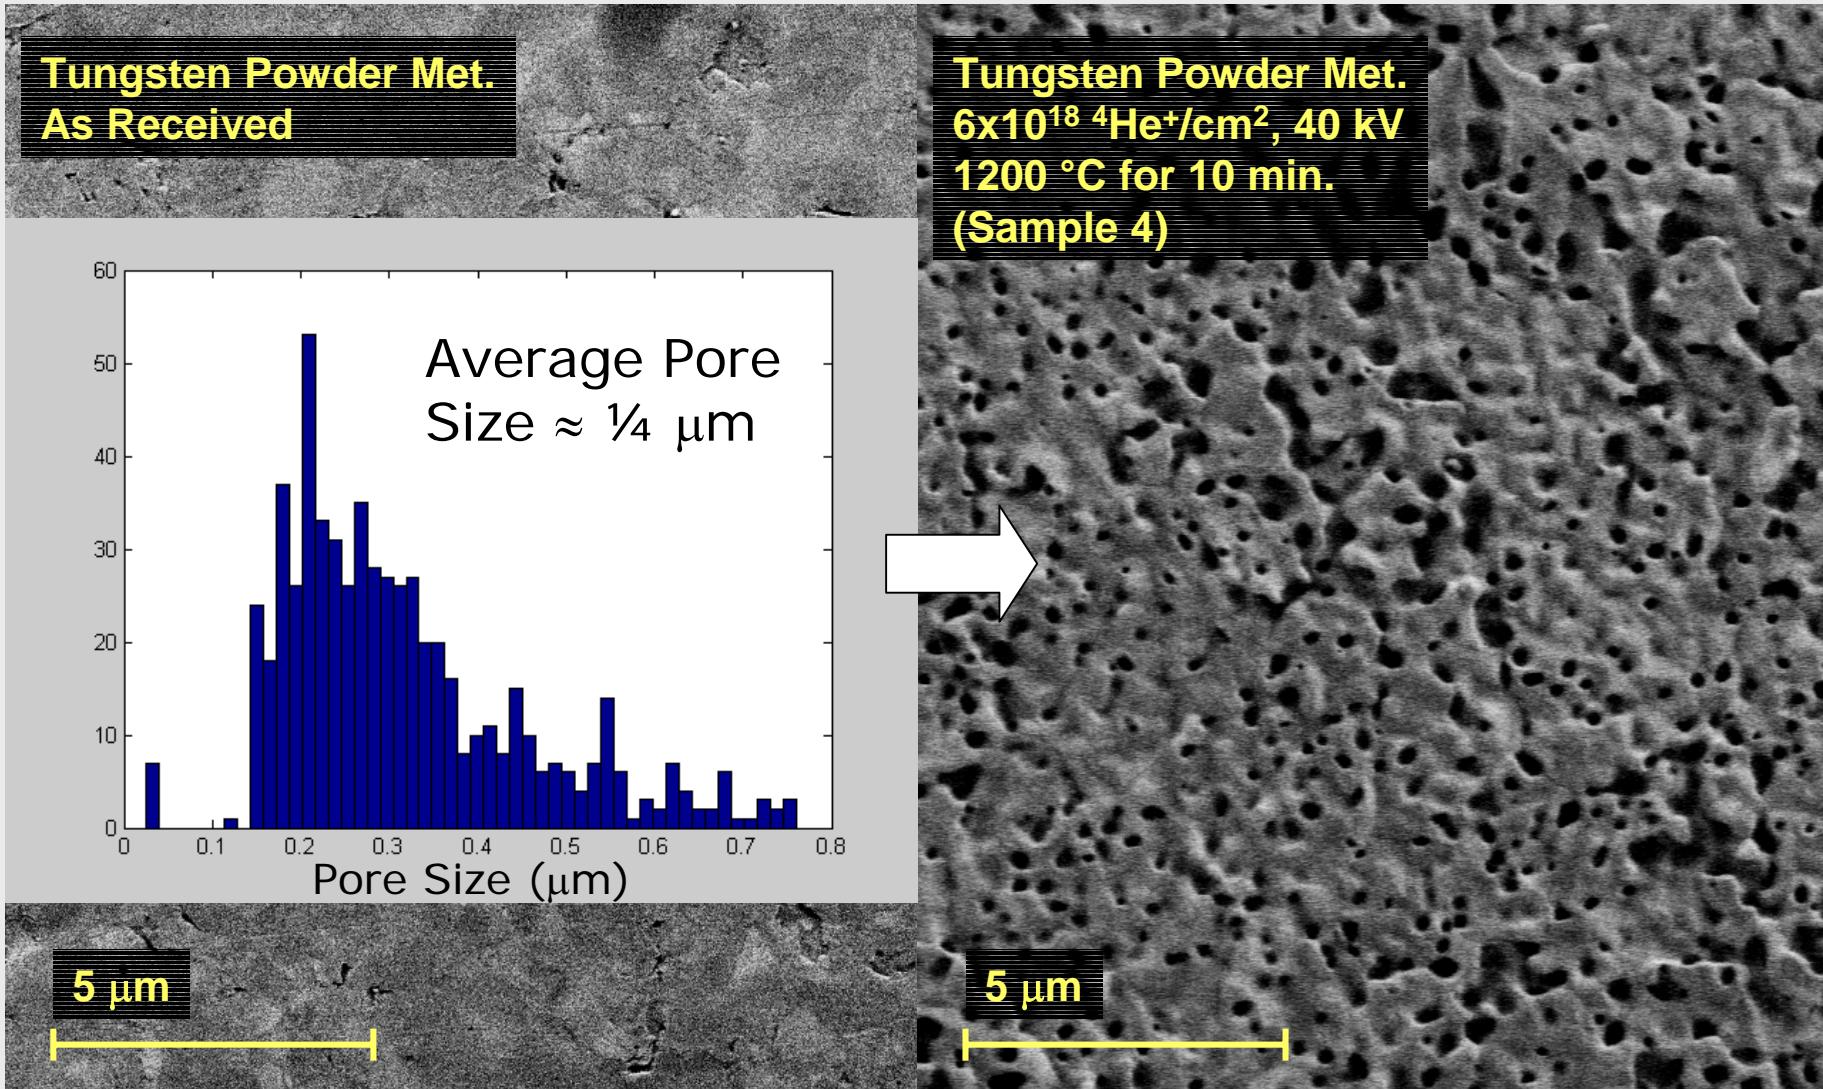
High Temp. Helium Implantation at 6×10^{18} $^4\text{He}^+/\text{cm}^2$ Created Porous Surface Structure

At 1200 °C,
 6×10^{18} He⁺/cm²
implantation
produced
“pinhole” porous
surface structure

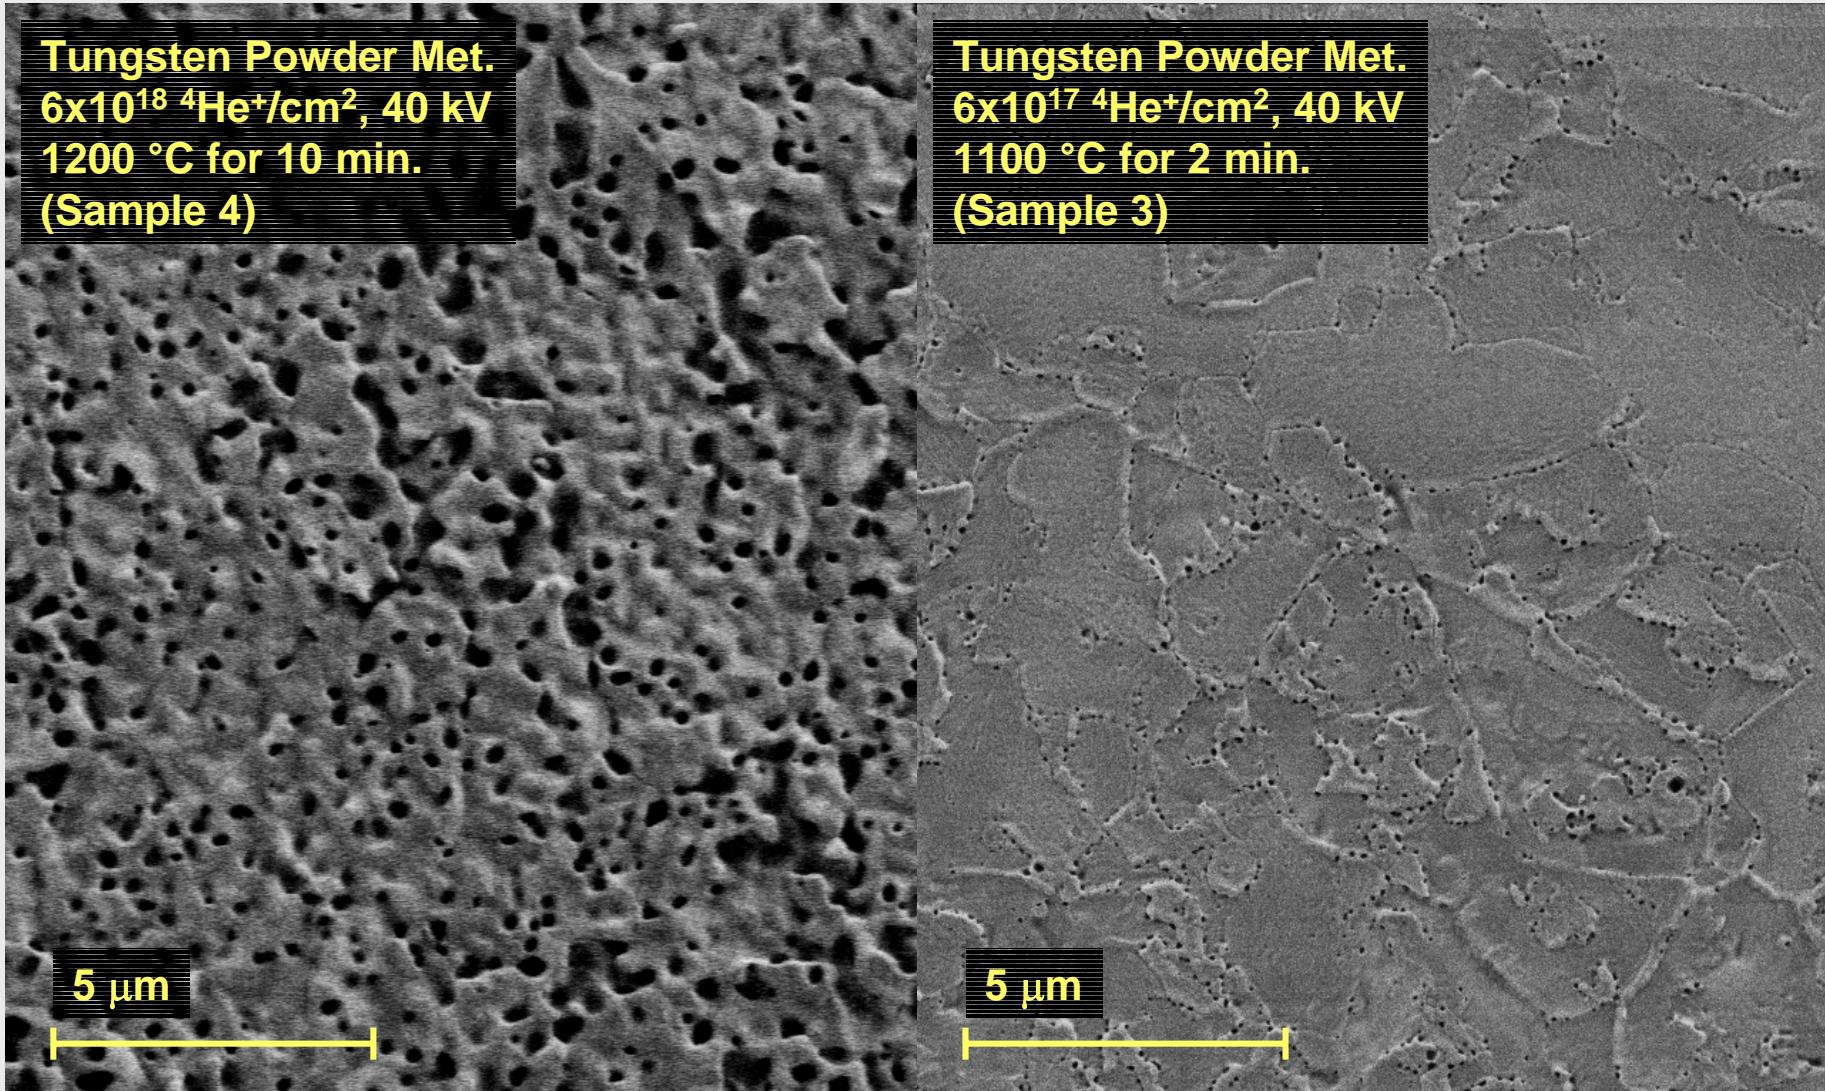
Pores Decorate Grain Boundaries at Lower Ion Fluence ($6 \times 10^{17} \text{ }^4\text{He}^+/\text{cm}^2$)

At 1100 °C,
 6×10^{17} He⁺/cm²
implantation
produced helium
bubbles that
decorate the
grain boundaries

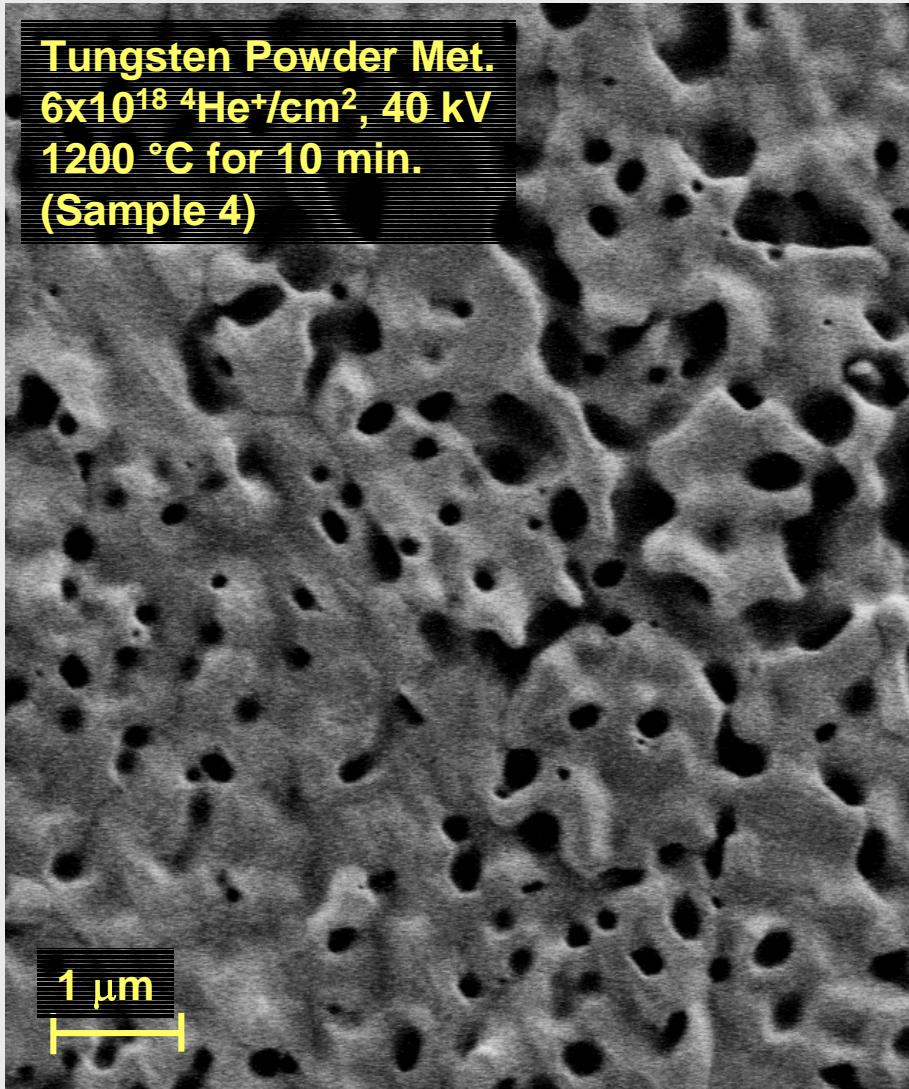
Tungsten Powder Met.
 $6 \times 10^{18} \text{ }^4\text{He}^+/\text{cm}^2$, 40 kV
1200 °C for 10 min.
(Sample 4)

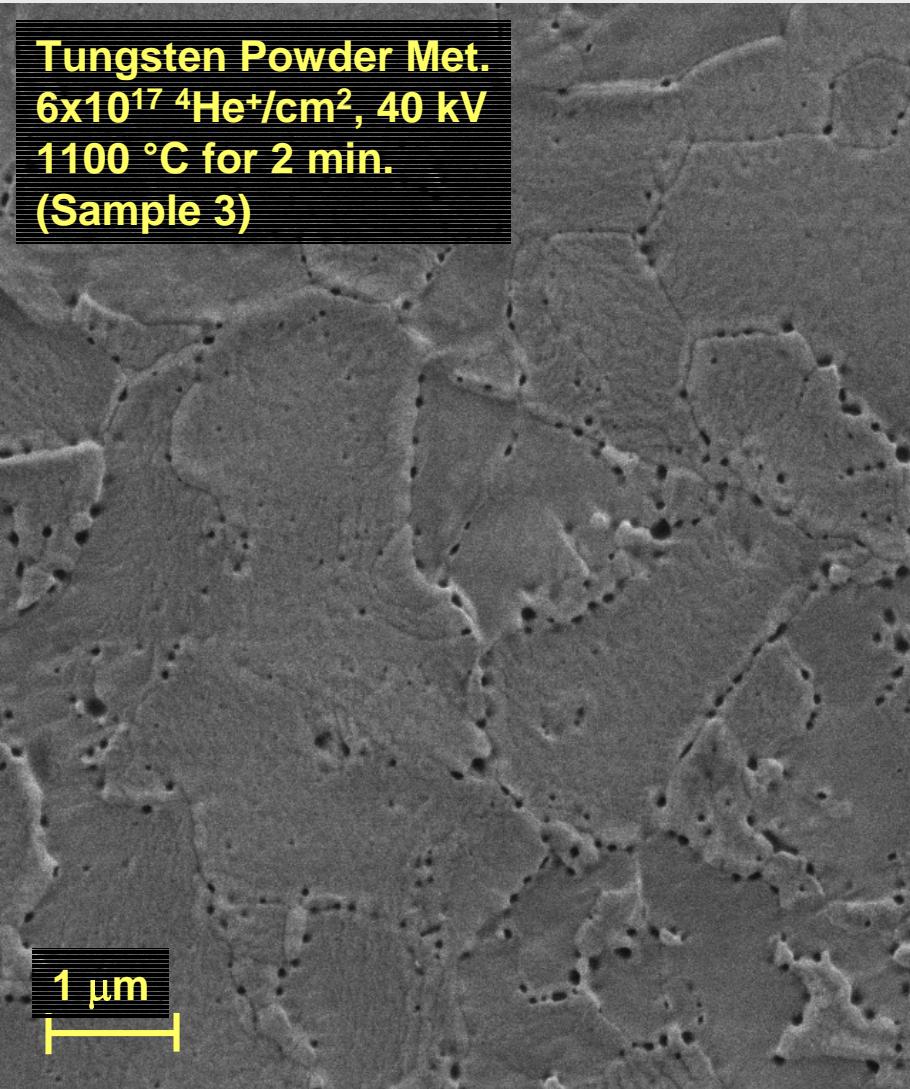
Tungsten Powder Met.
 $6 \times 10^{17} \text{ }^4\text{He}^+/\text{cm}^2$, 40 kV
1100 °C for 2 min.
(Sample 3)

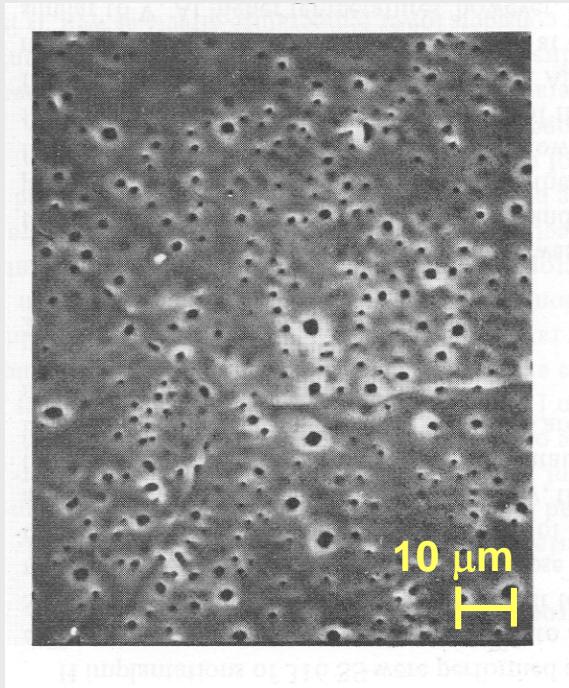
Pinhole Structure Seen 30 Years Ago

Vanadium @ 1200 °C
300 keV He⁺ 2×10^{18} ions/cm²

- “Pinhole” structure shown by the work of Thomas and Bauer on Vanadium (1974)
- Authors’ Conclusions:
 - At high temperatures, bubbles intersect the surface to form the porous structure
 - This porous structure is stable and results in 100% helium re-emission

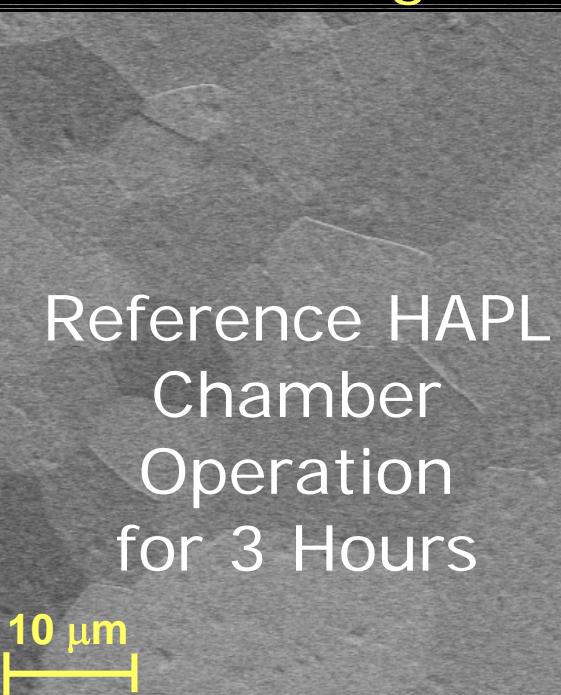
At 1100-1300 °C,
 2×10^{19} D⁺/cm²
implantation
produced no
blistering

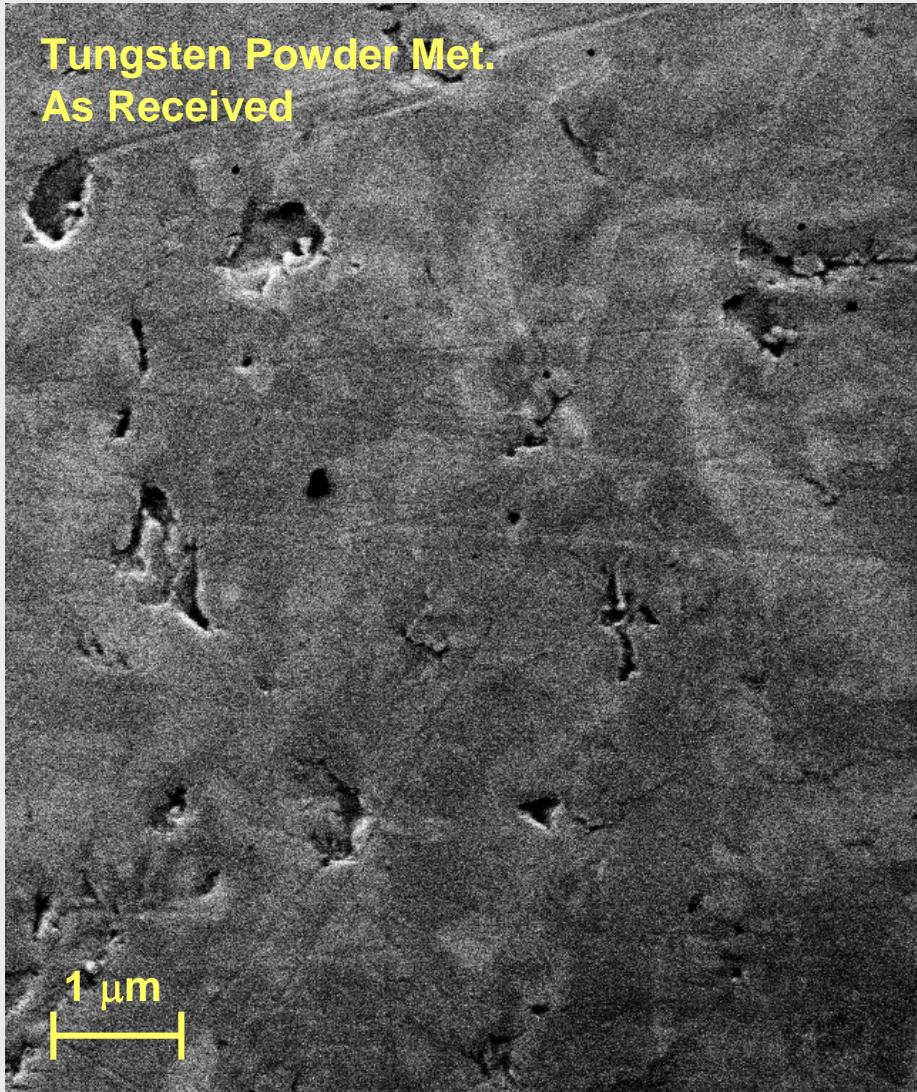
Deuterium Did Not Cause Blistering But Caused Substantial Grain Growth

Tungsten Powder Met.
As Received

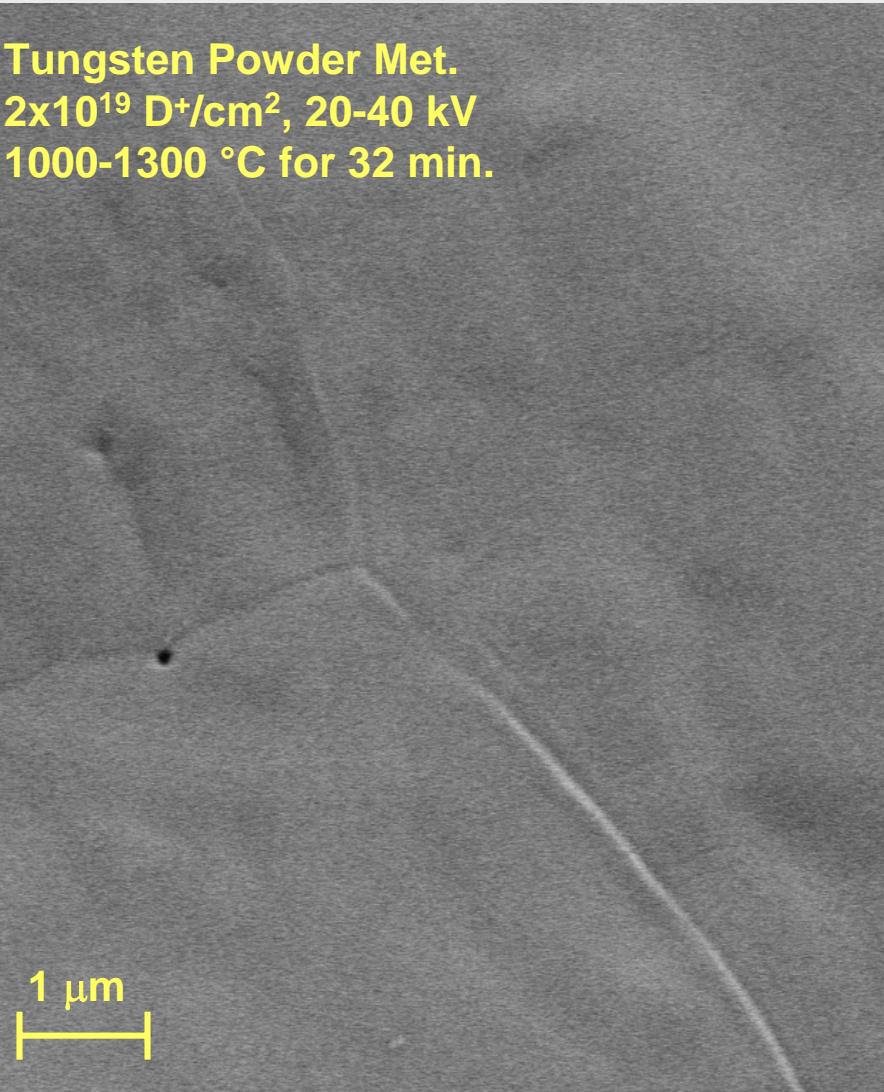
Tungsten Powder Met.
 $2 \times 10^{19} D^+/\text{cm}^2$, 20-40 kV
1000-1300 °C for 32 min.
