**Preliminary Results for Steady State
Implantation of He⁺ and D⁺ in
Carbon Velvet and W – Coated
Carbon Velvet**

HAPL Meeting-PPPL

December 13th, 2006

**Fusion Technology Institute
University of Wisconsin-Madison**

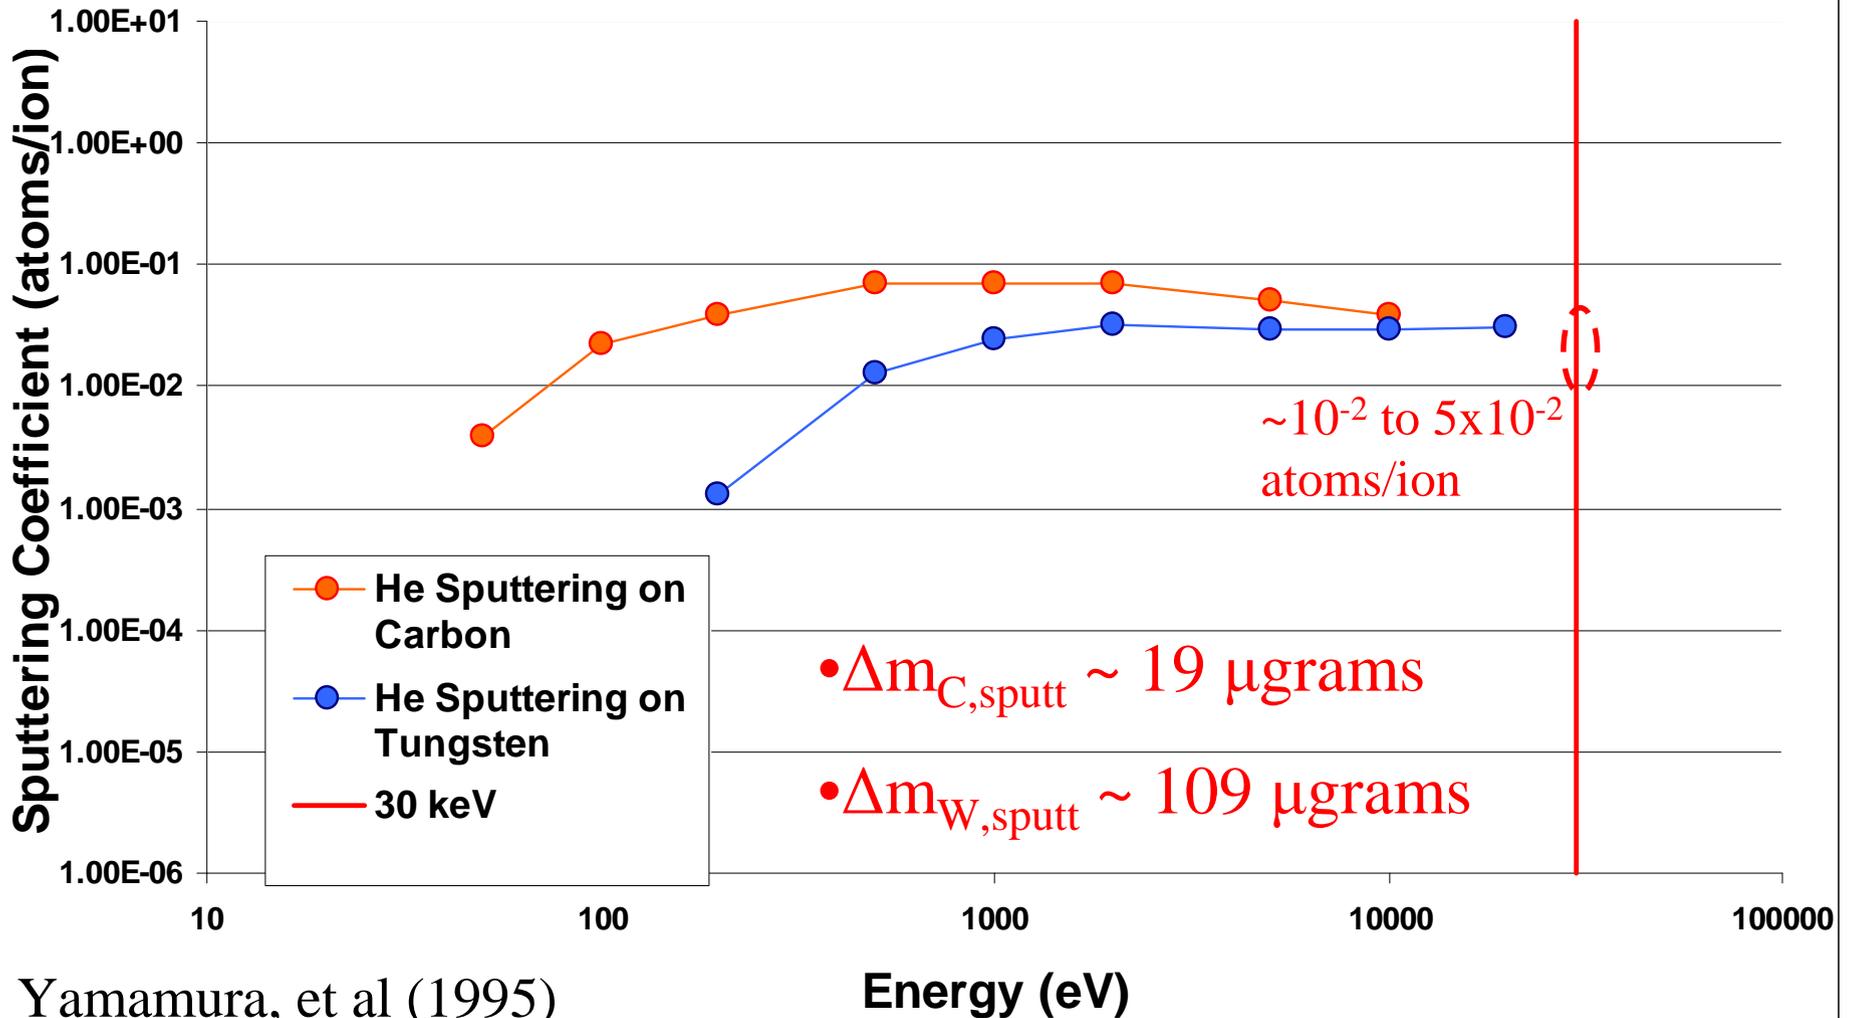
At 30 keV He⁺ Has a Similar Sputtering Yields on Carbon and Tungsten

Helium Sputtering Coefficients

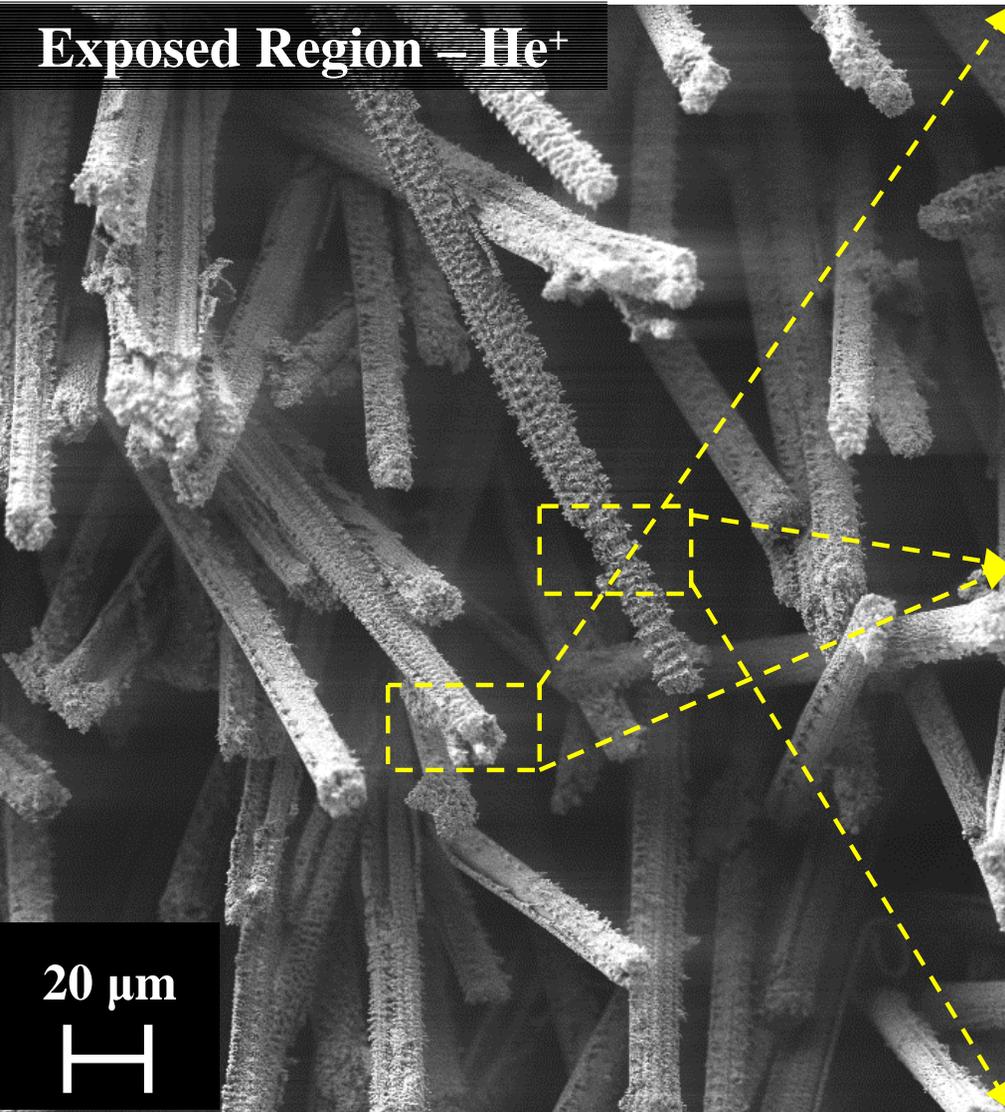
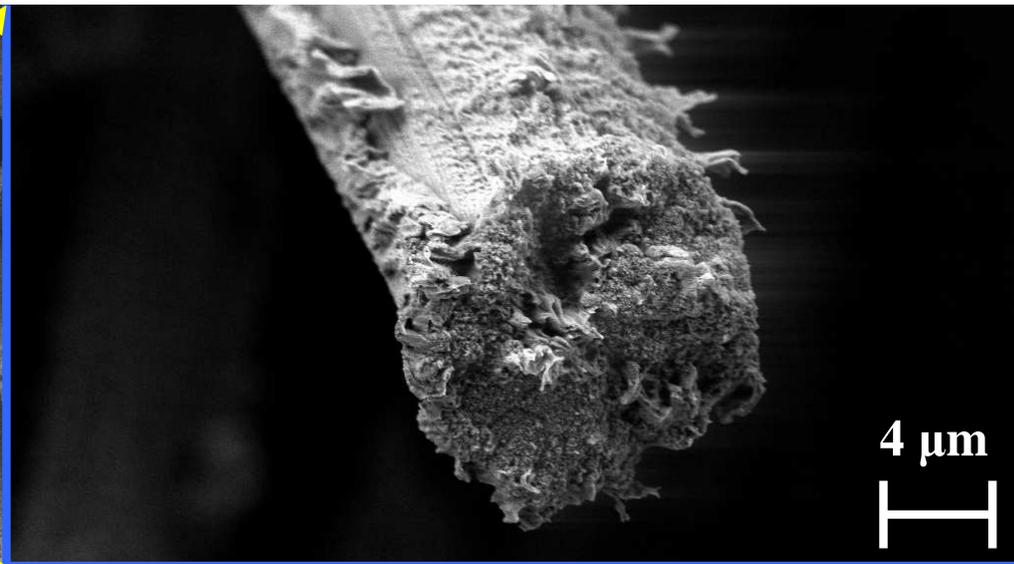
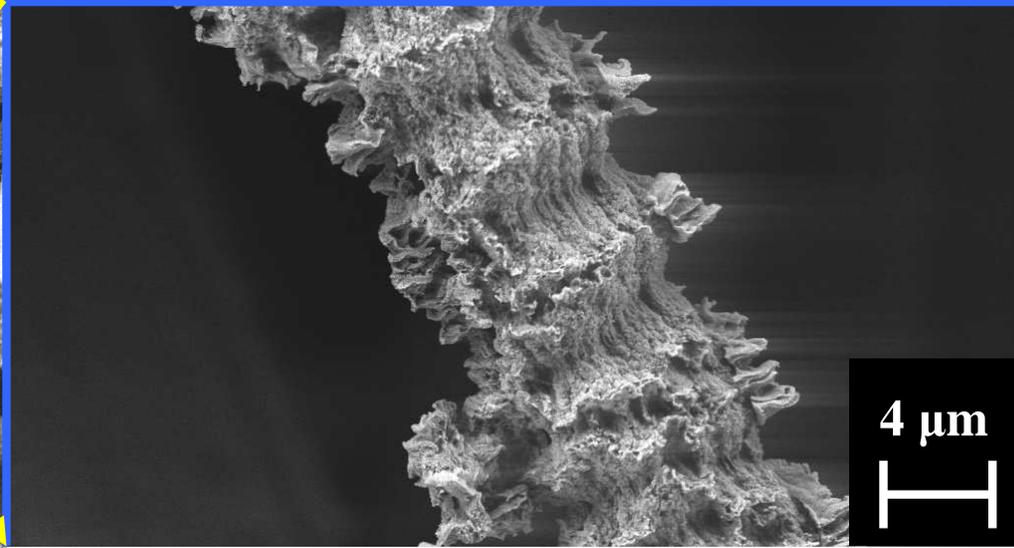
Irradiation of CCV to 10^{19} He⁺/cm² Results in Surface Roughness and Shaft Corrugation

Exposed Region – He⁺

$T \sim 1150$ °C, $\phi \sim 10^{19}$ He⁺/cm², $V \sim 30$ kV

- Both He^+ and D^+ irradiation of carbon-carbon velvet specimens causes fiber shaft corrugation, though He^+ irradiated samples have a more pronounced effect
- Some W-coated carbon fiber shafts incur rupturing, in addition to increased W surface roughness after He^+ irradiation
- Both He^+ and D^+ irradiation resulted in measurable mass loss in each of the carbon velvet specimens
- Masked sections of all carbon velvet specimens exposed to high temperature and high voltage, sustained less damage (quantitative), as well as a qualitatively different surface structure than exposed sections

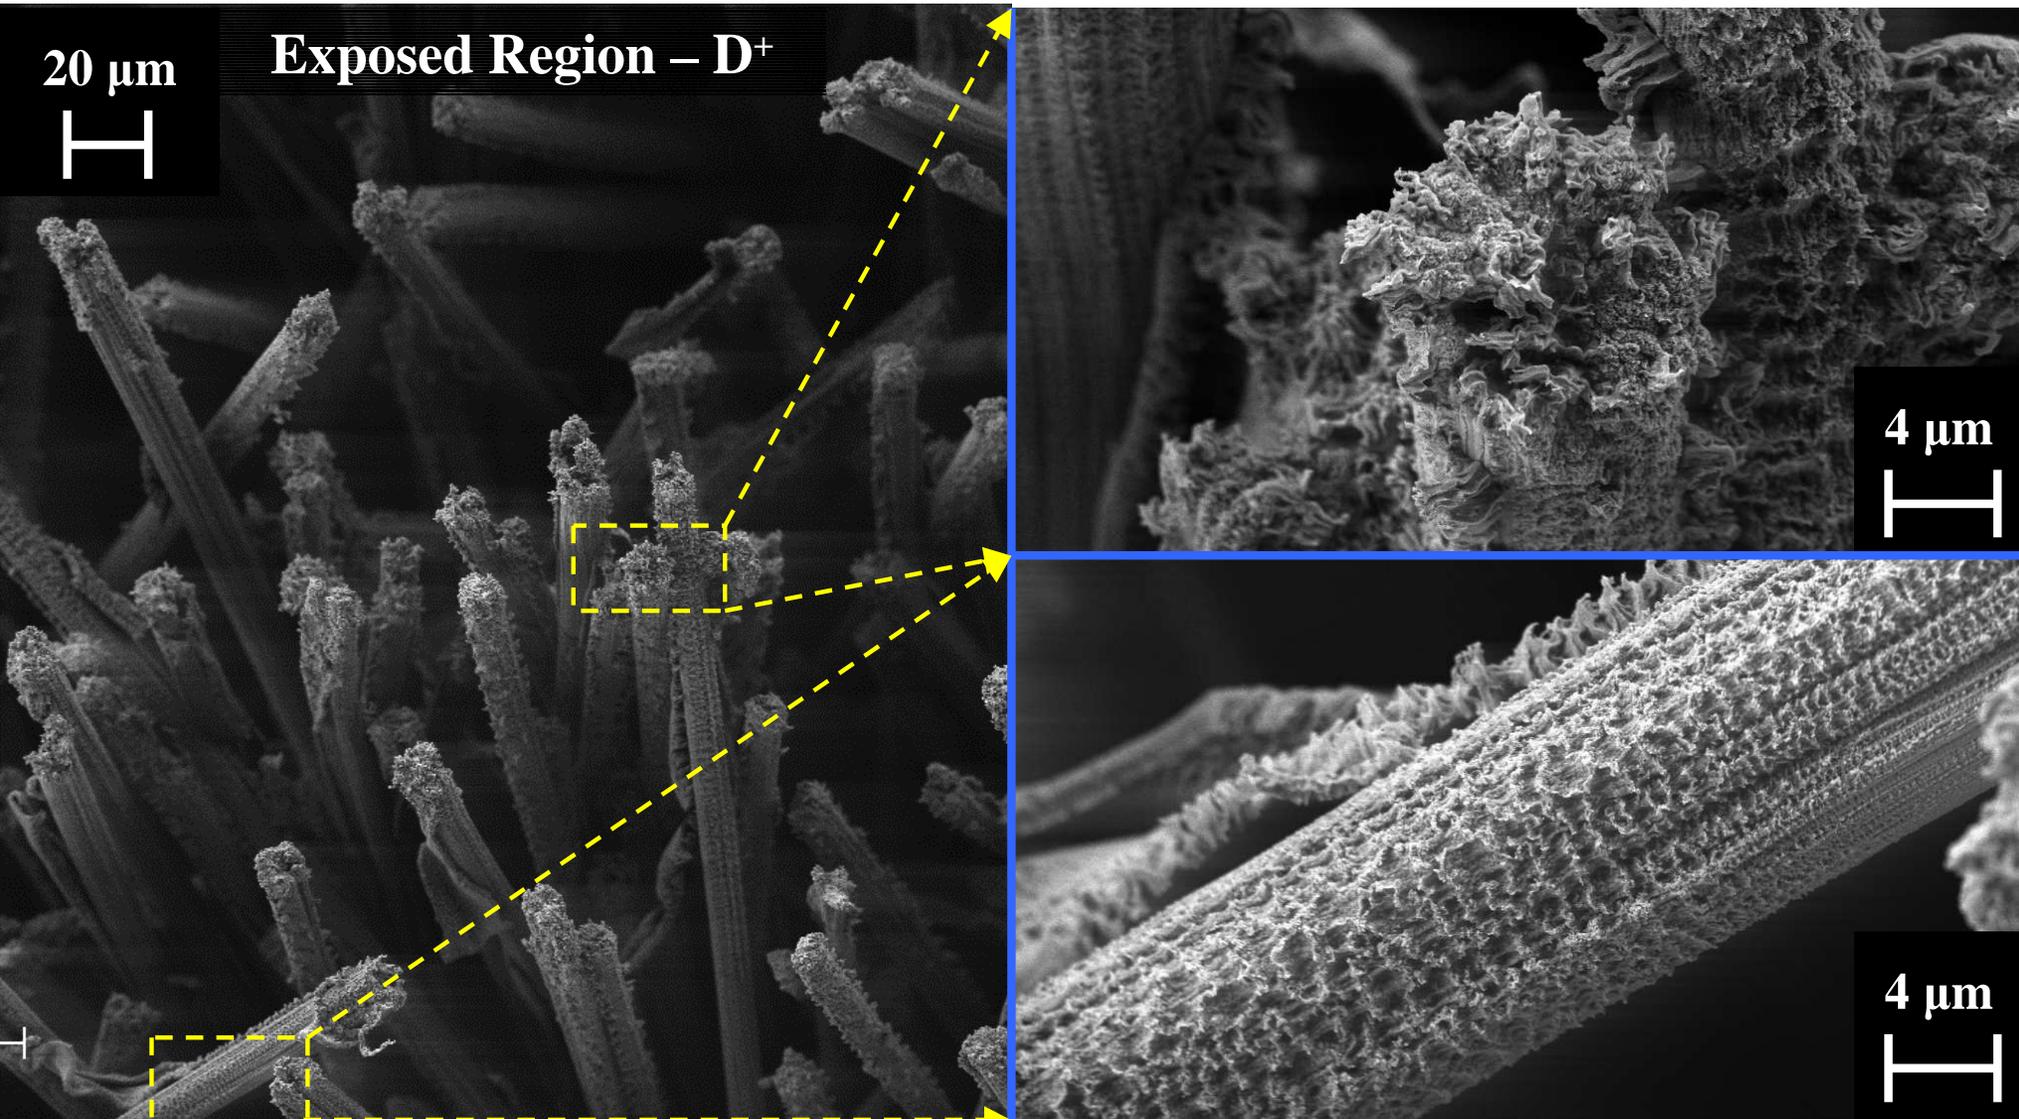
Irradiation of CCV to 10^{19} D⁺/cm² also Results in Surface Roughness

T ~ 1150 °C, ϕ ~ 10^{19} D⁺/cm², V ~ 30 kV

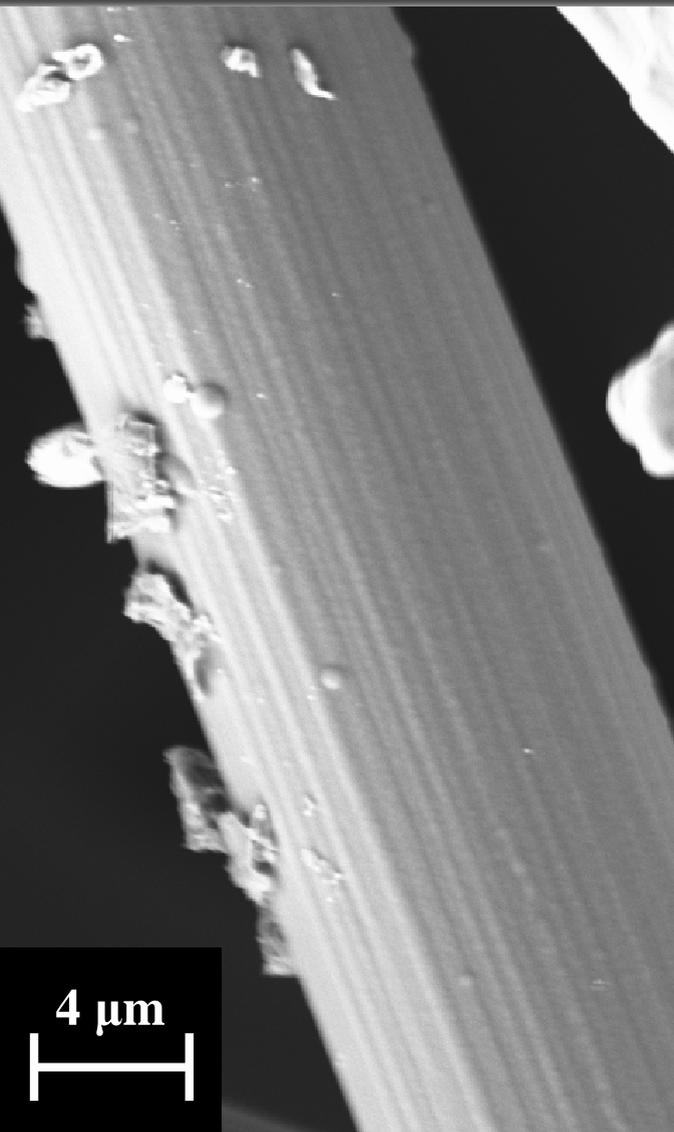
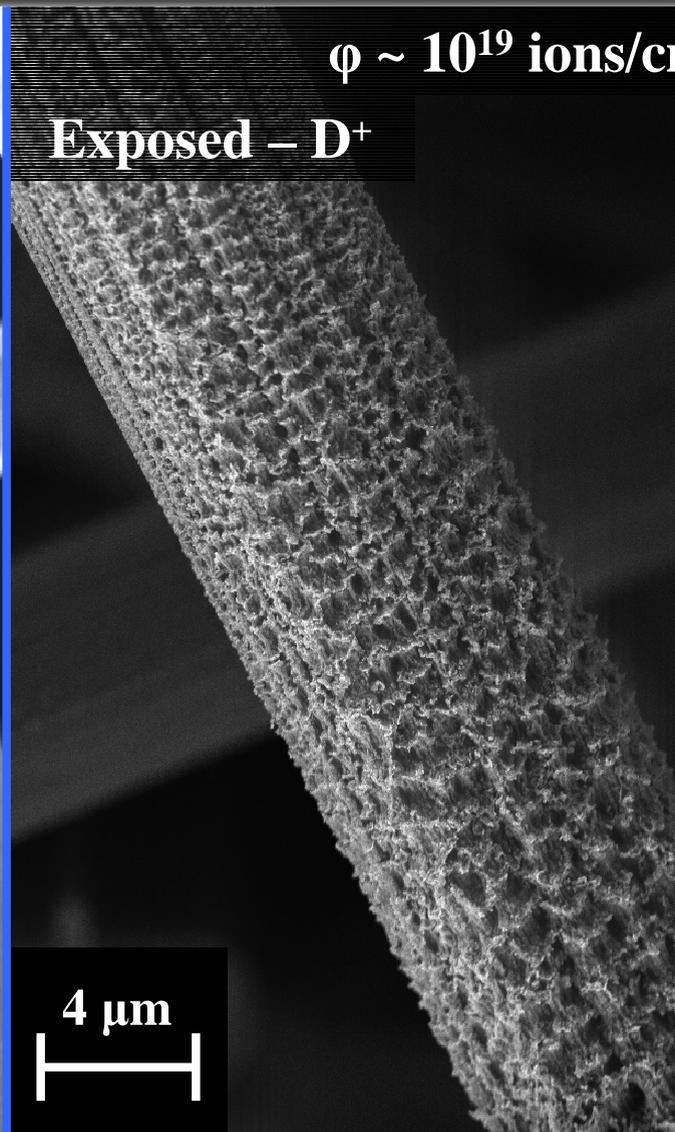
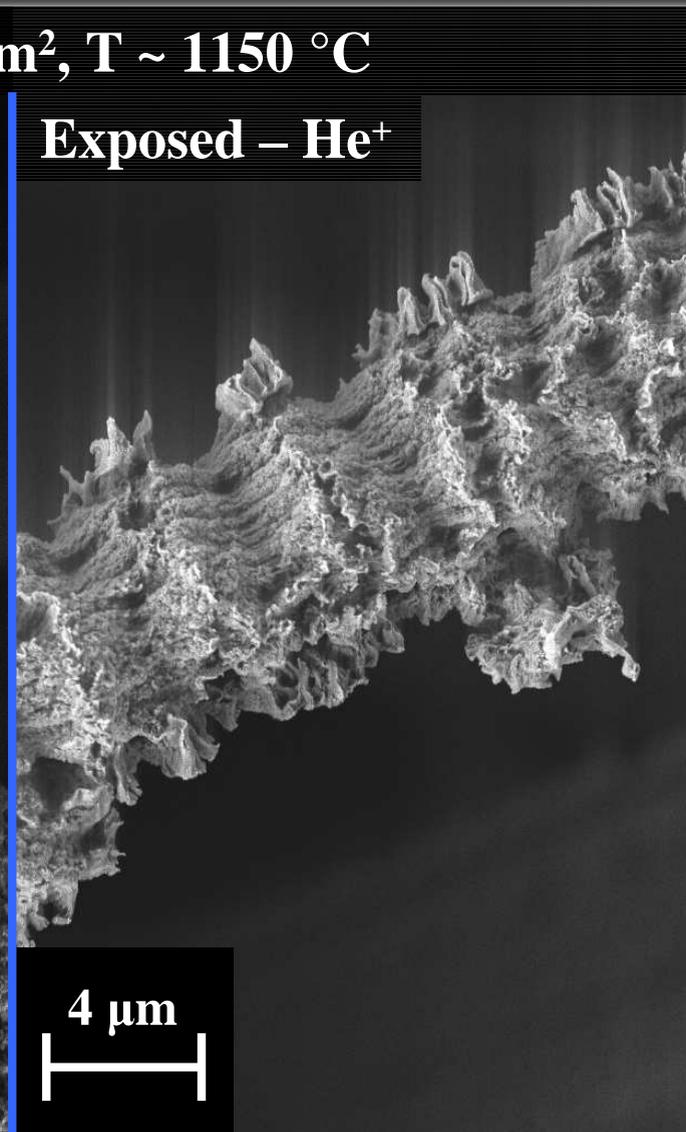
CCV Exposure to He^+ Fluxes Shows an Increase in Fiber Surface Roughening Compared to D^+ Fluxes

CCV Unirradiated

CCV – 10^{19} D^+ /cm²

CCV – 10^{19} He^+ /cm²

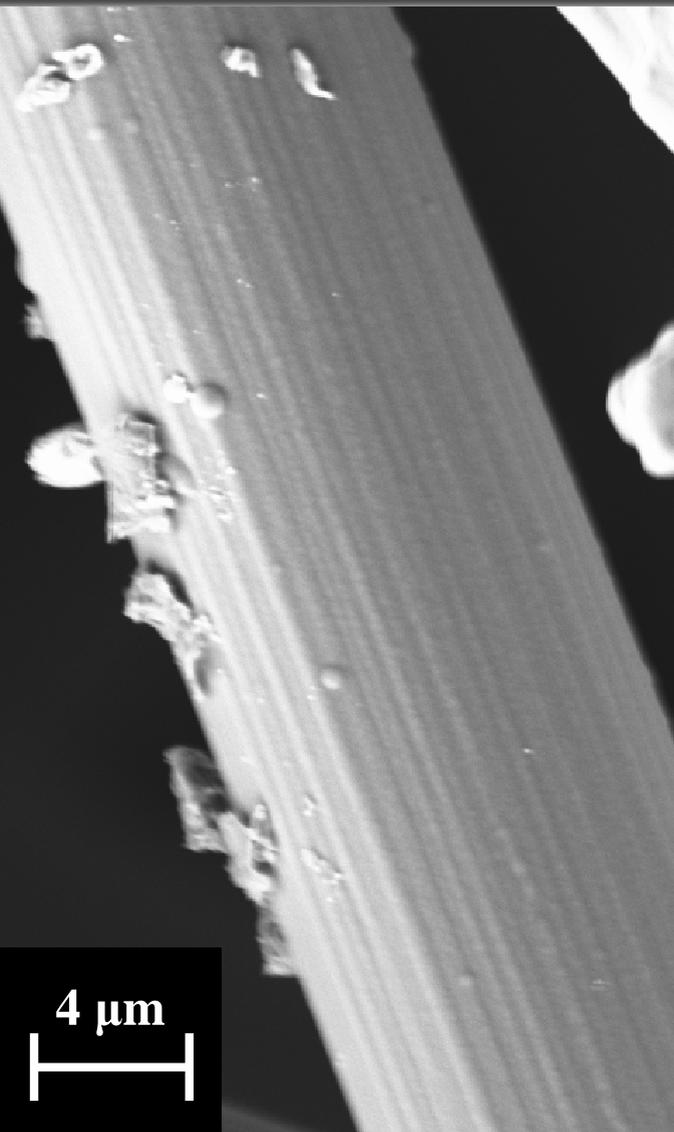
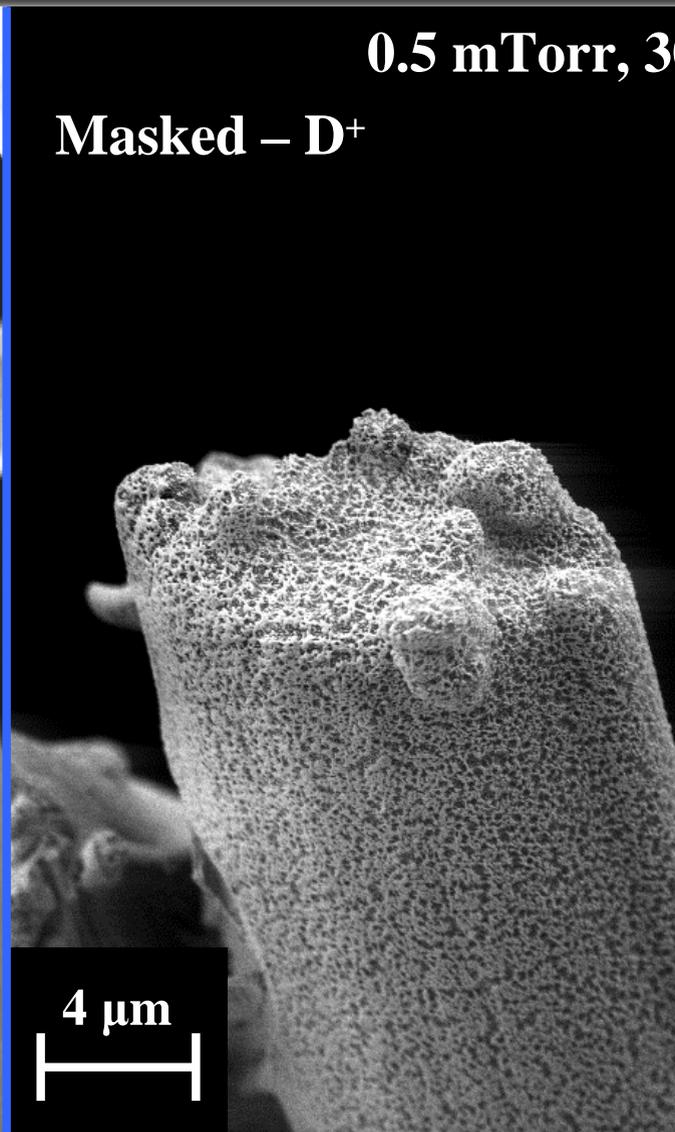
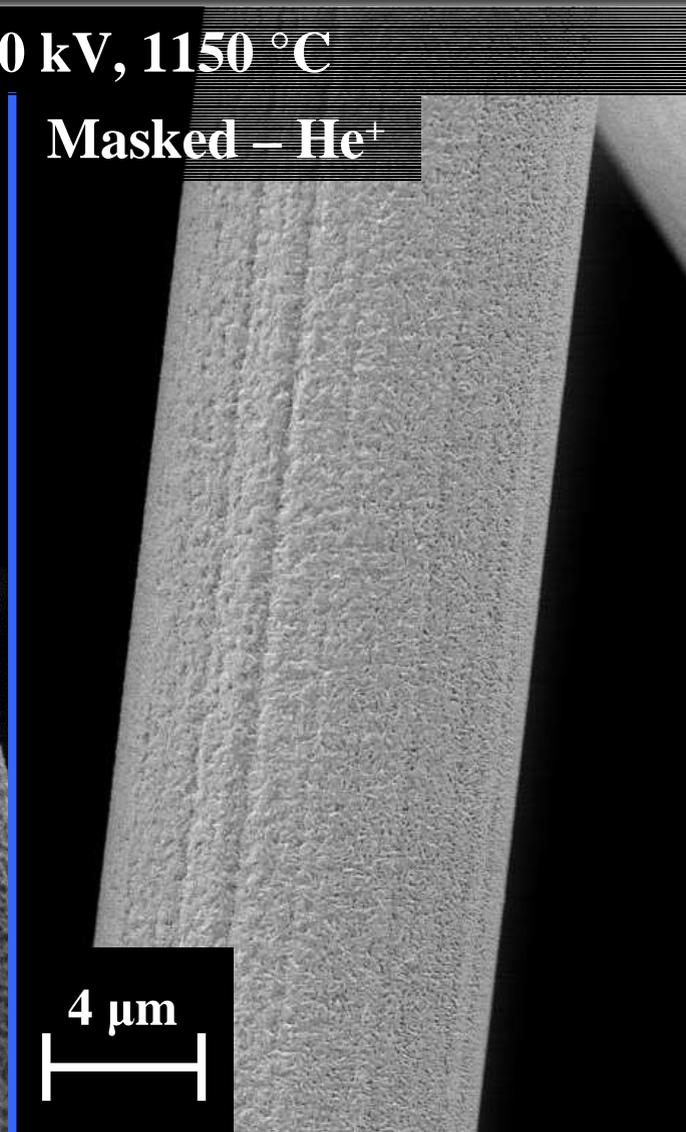
Similar Surface Modification Occurs in the Masked Region of CCV Samples Exposed to He⁺ and D⁺ Fluxes

CCV Unirradiated

CCV – 108 min. runtime

CCV – 87 min. runtime

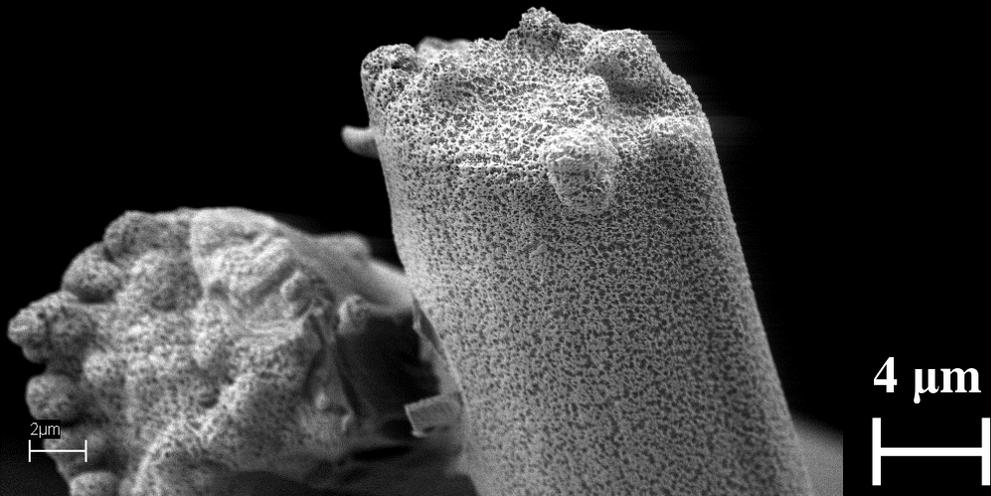
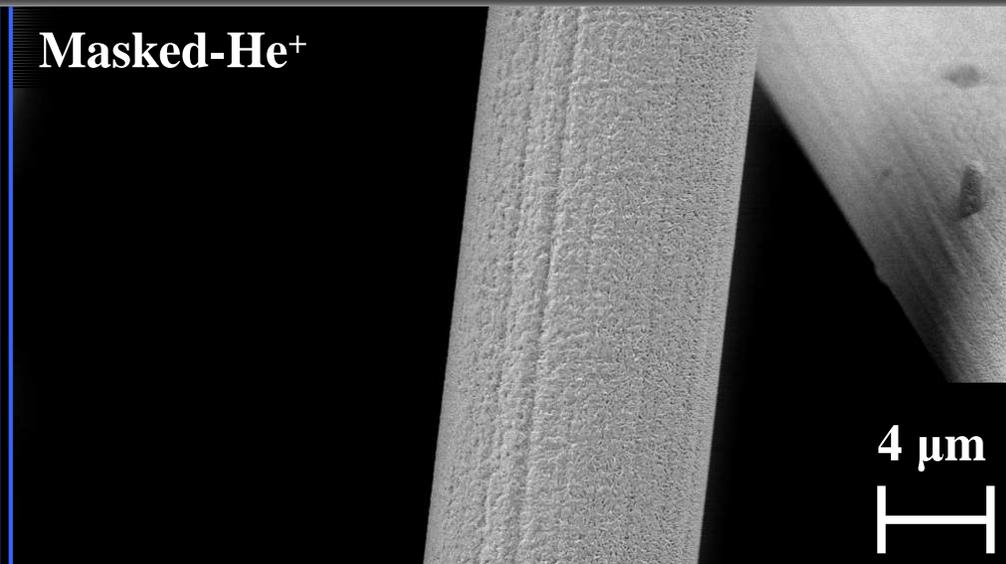
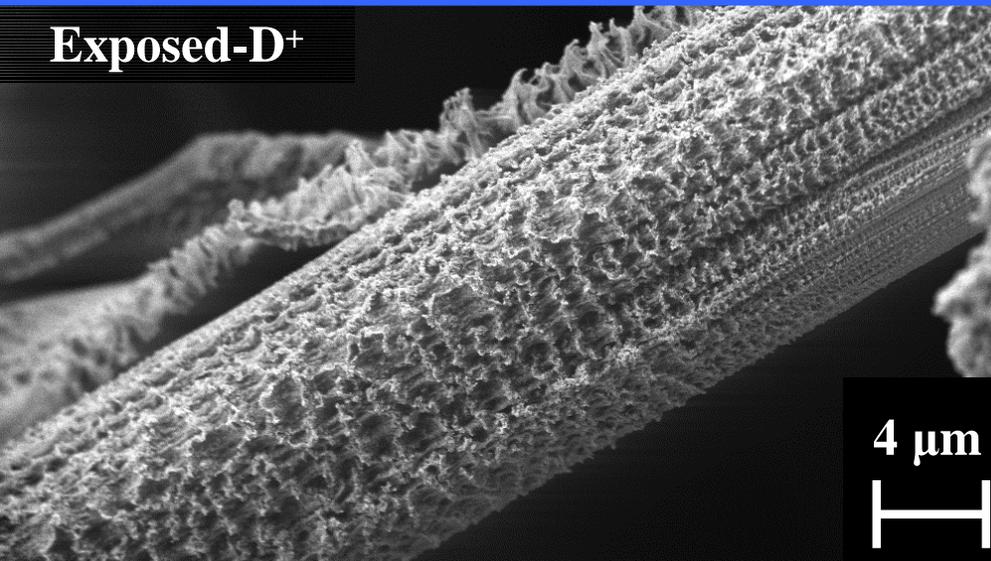
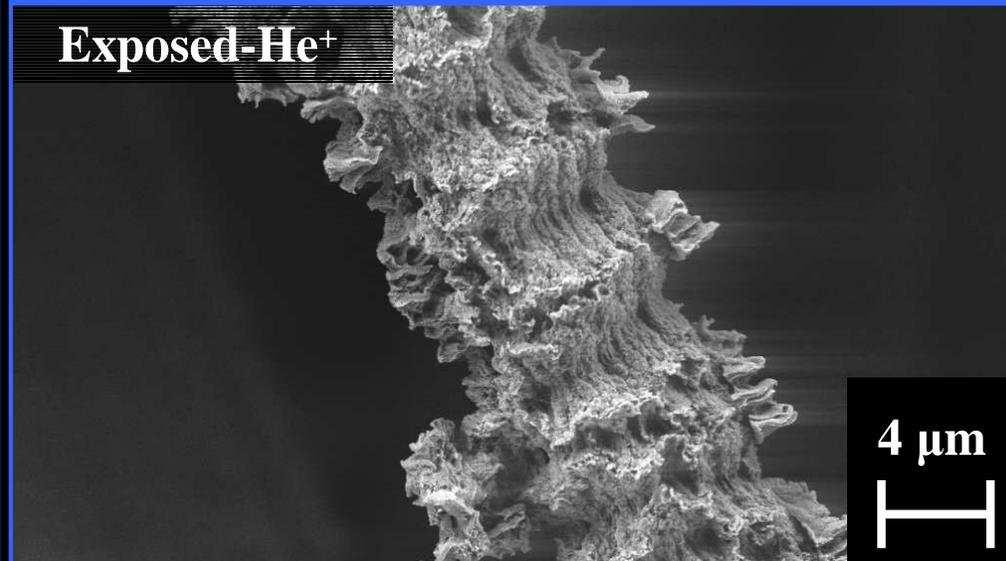
Drastic Differences in CCV Surface Morphology Are Evident Between the Exposed and Masked Regions

CCV – Irradiated to 10^{19} D⁺/cm² @ 1150 °C

CCV – Irradiated to 10^{19} He⁺/cm² @ 1150 °C

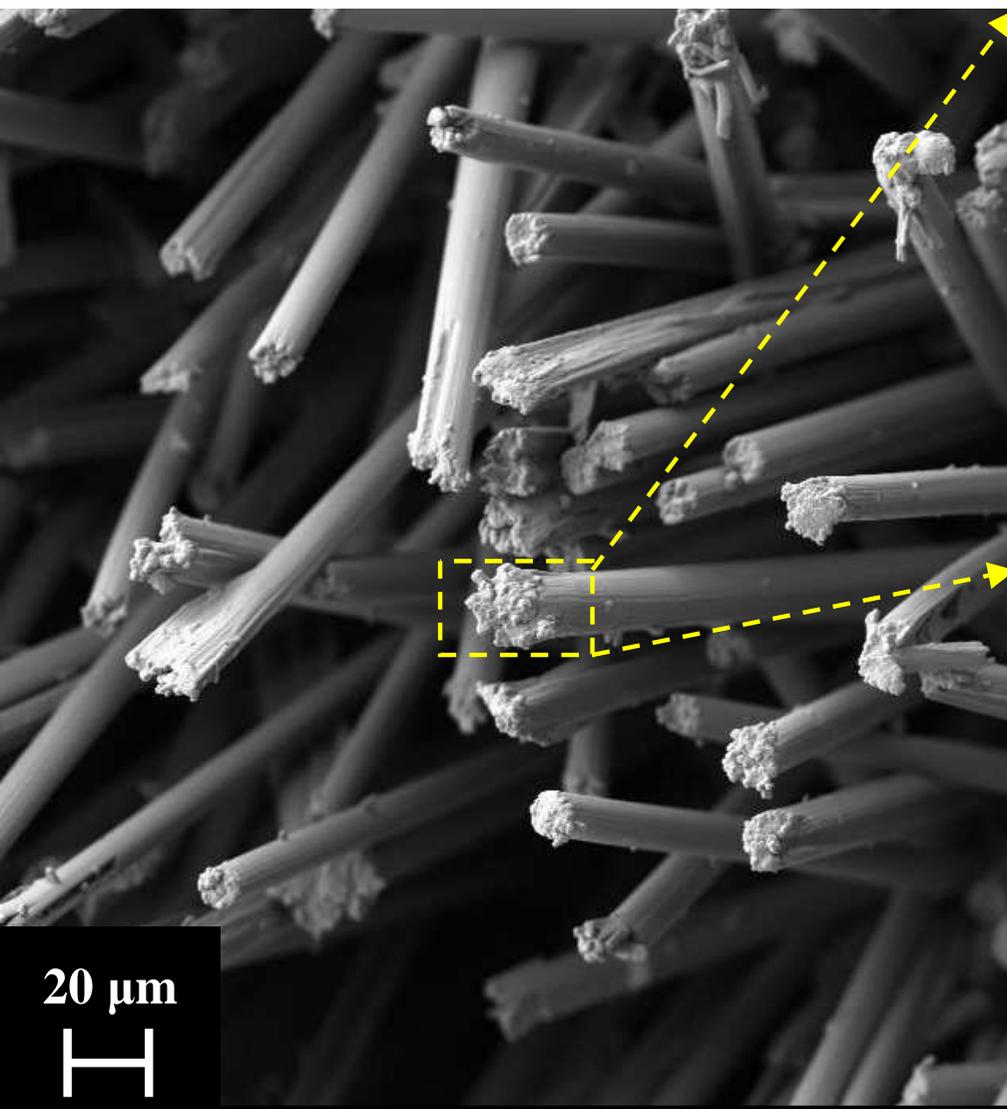
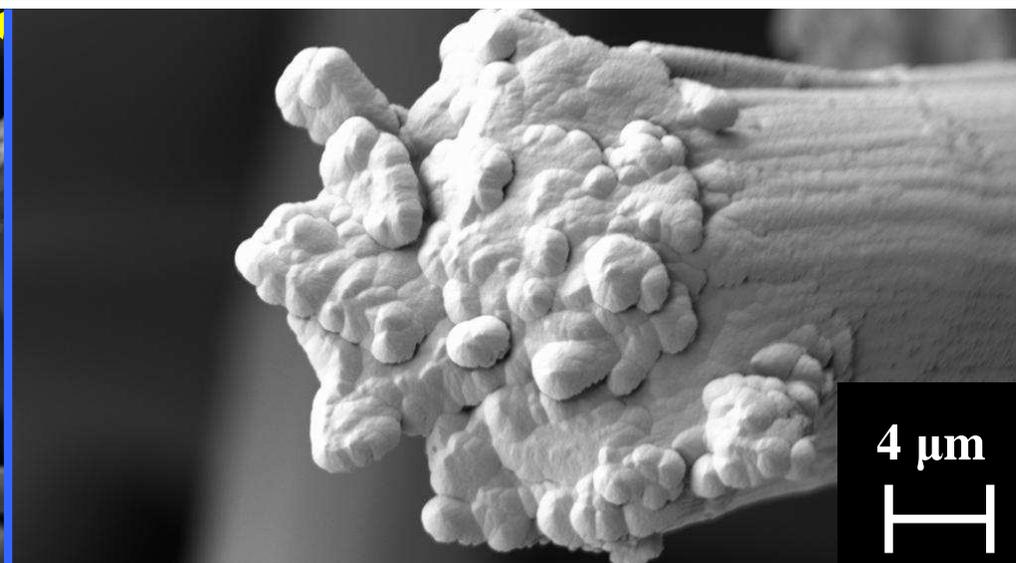
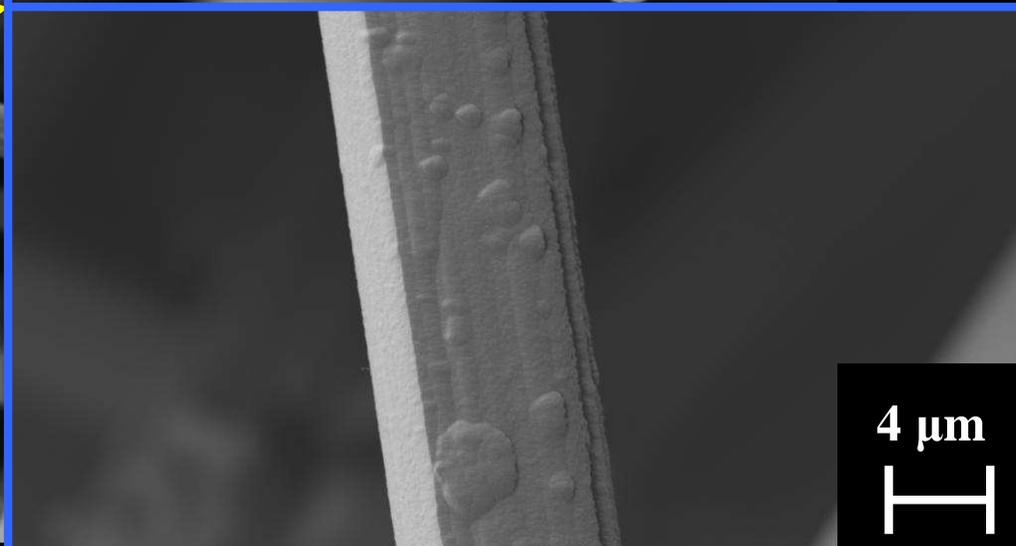
Unirradiated Tungsten – coated Carbon Velvet

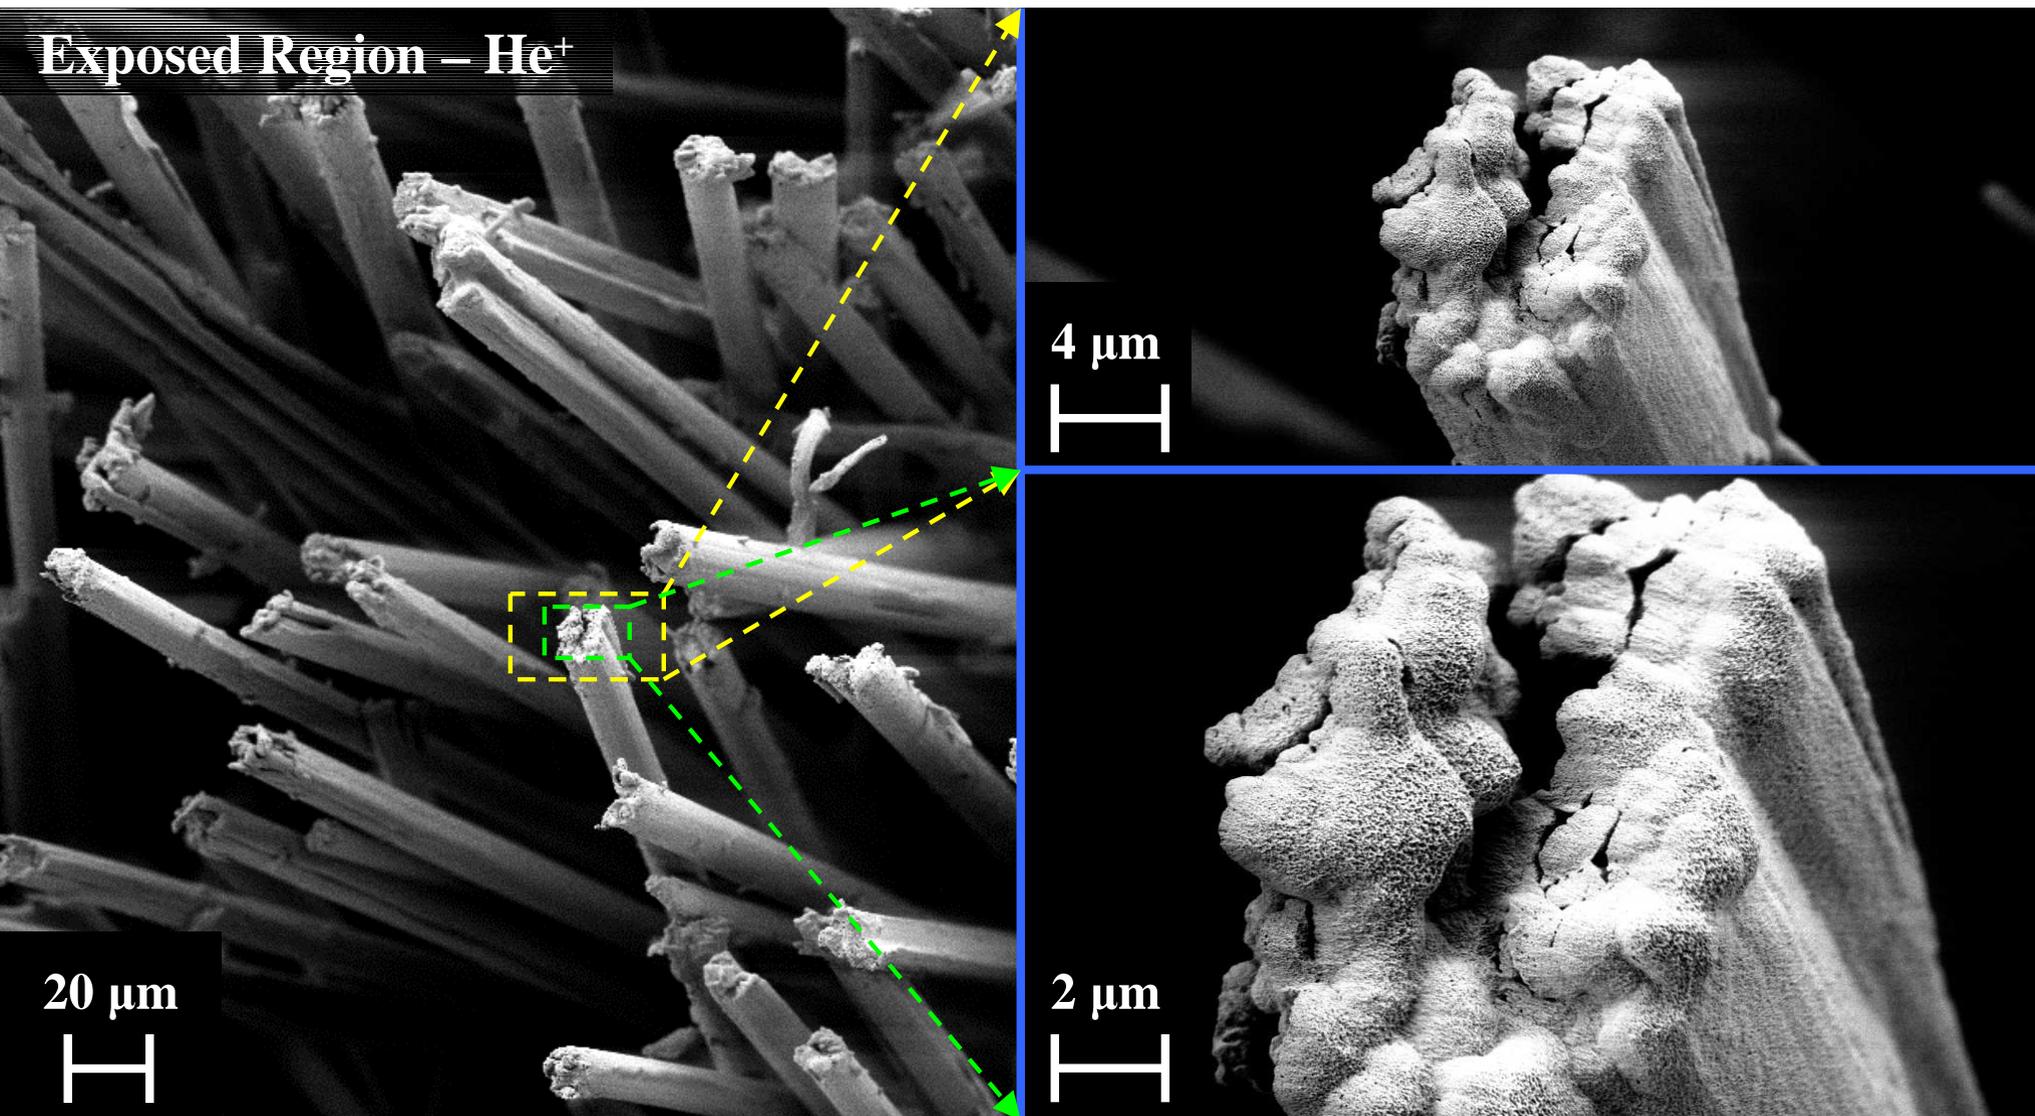
SEM Analysis Illustrates Increased Surface Roughening on W-Coating after Irradiation of W/CCV to 10^{19} He⁺/cm²

$T \sim 1150$ °C, $\phi \sim 10^{19}$ He⁺/cm², $V \sim 30$ kV

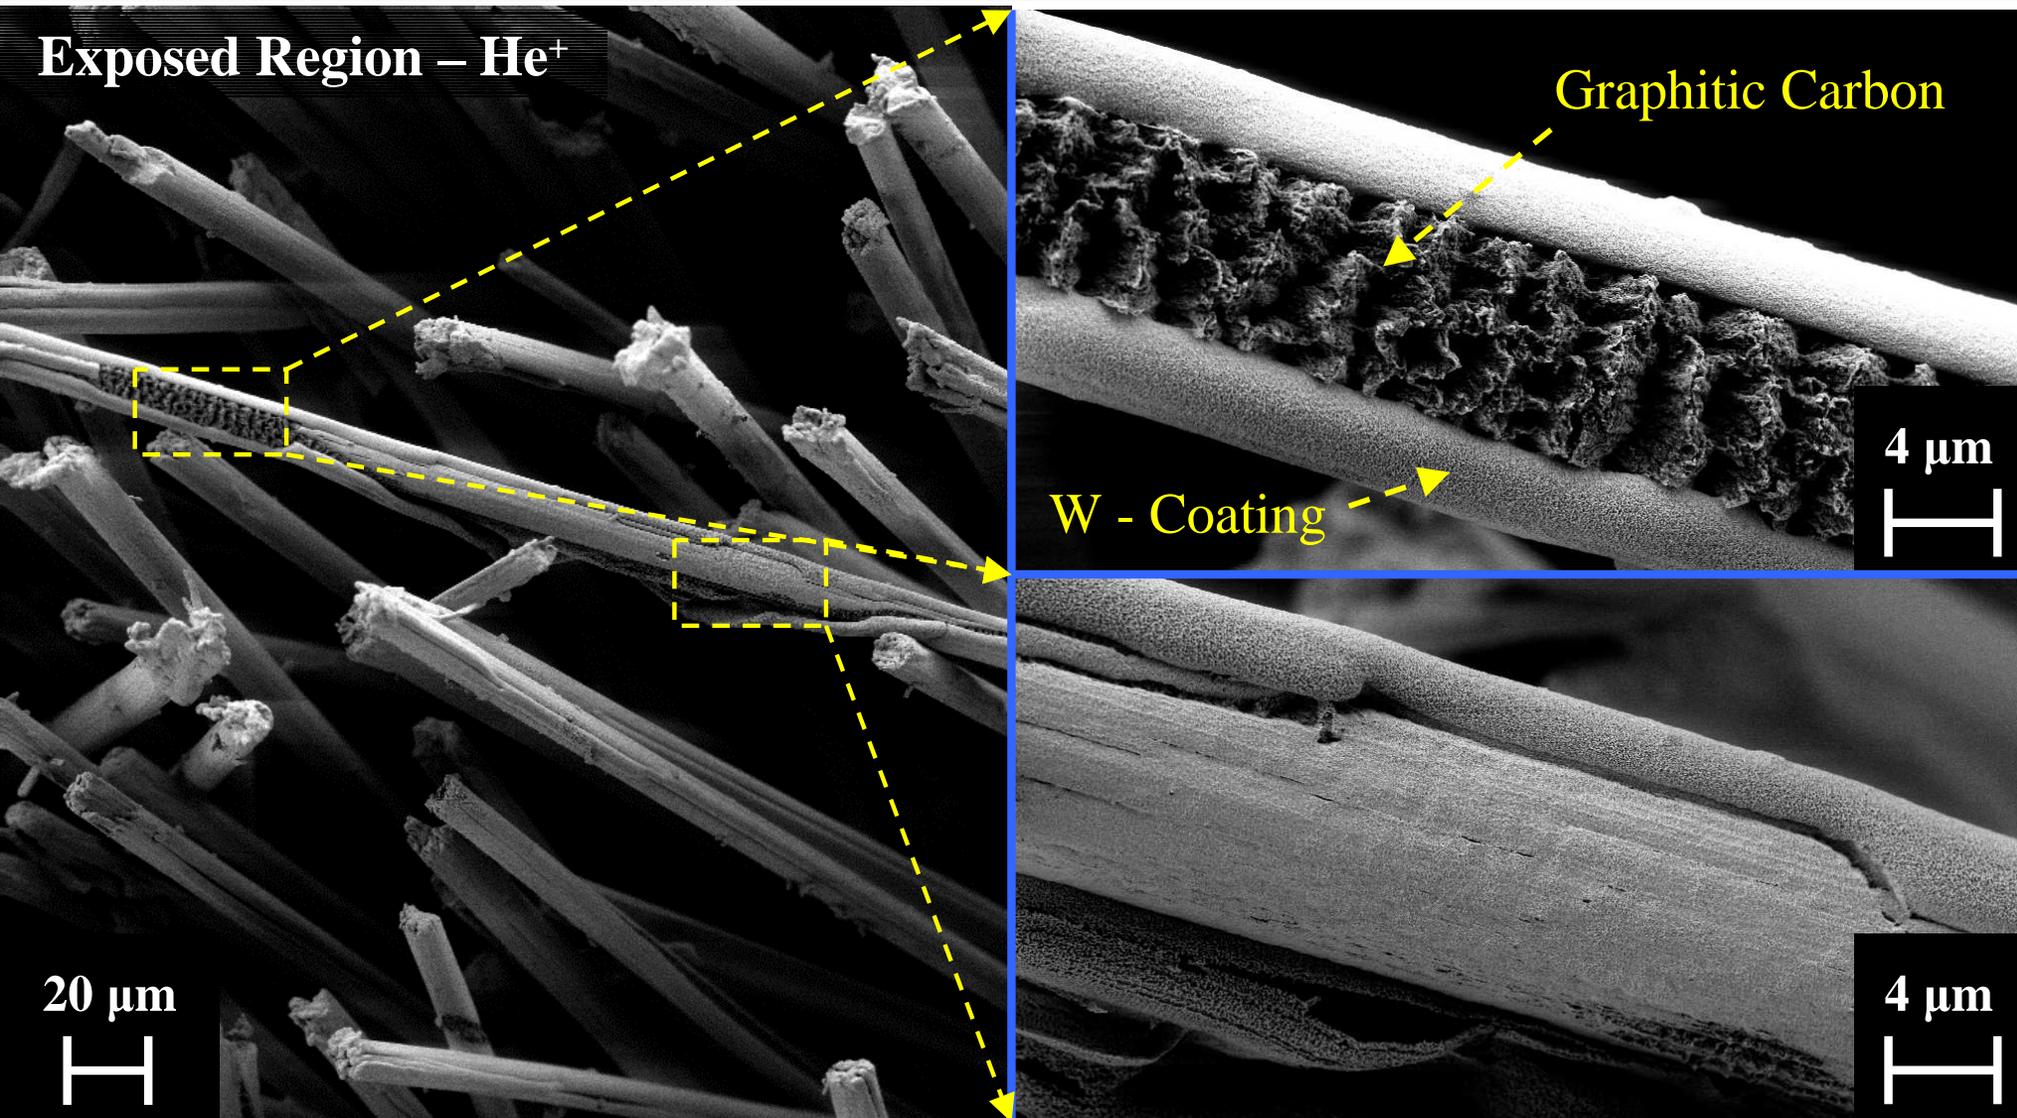
After Irradiation of W/CCV to 10^{19} He⁺/cm² Rupturing of the W-Coating is Also Observed

$T \sim 1150$ °C, $\phi \sim 10^{19}$ He⁺/cm², $V \sim 30$ kV

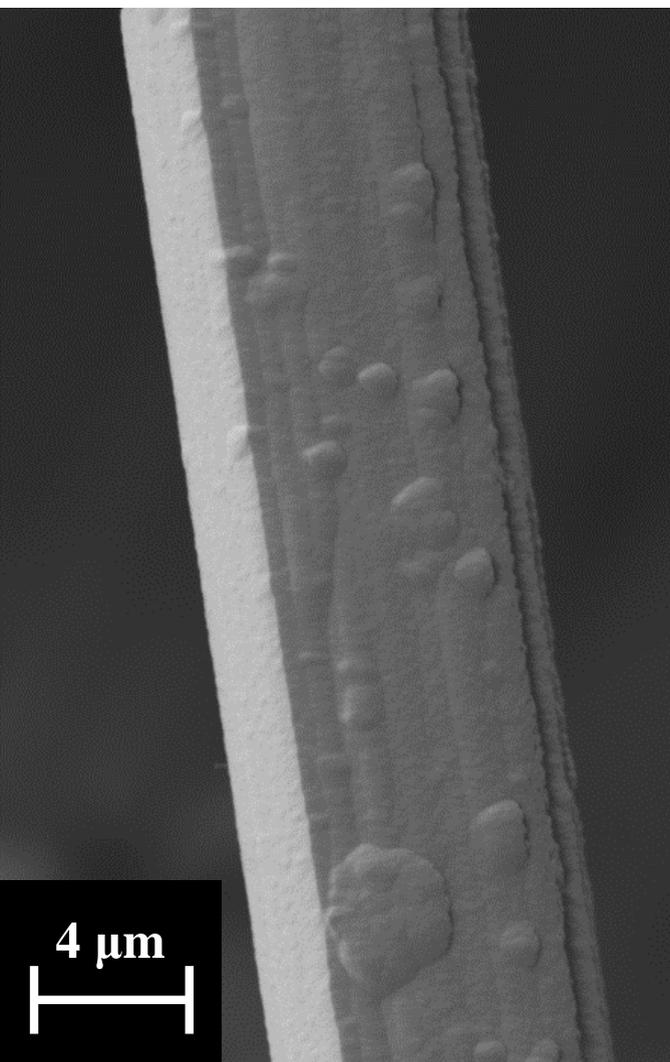
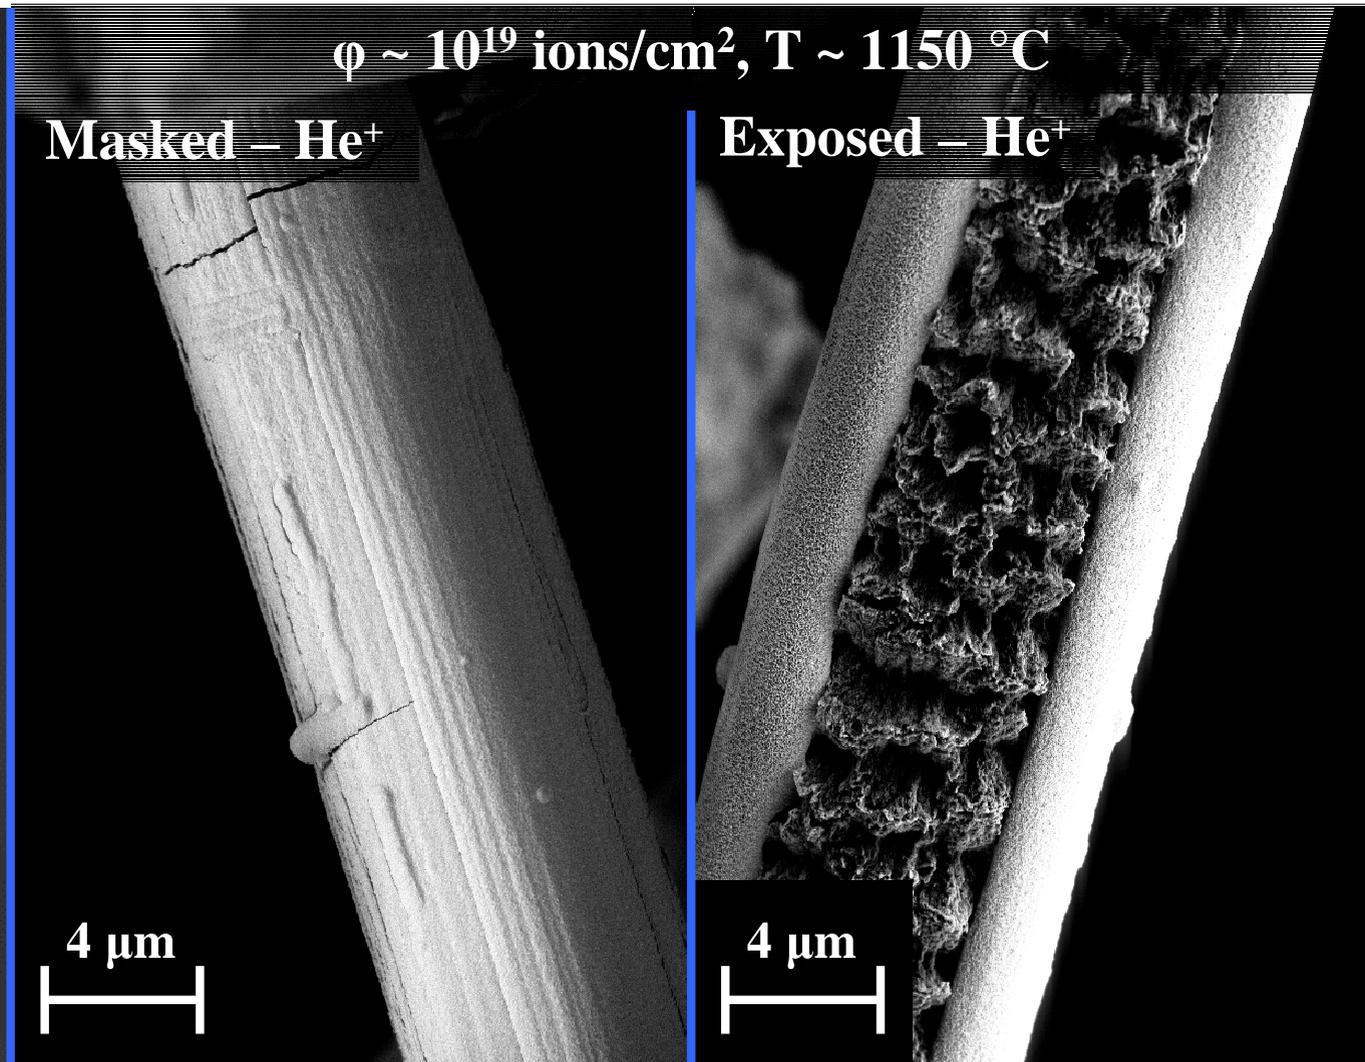
Masked W/CCV Experiences W-Coating Cracks But Not Increased Surface Roughness

W/CCV Unirradiated

W/CCV – 10^{19} He⁺/cm², 105 min. runtime
