**Preliminary Results for Steady State
Implantation of He⁺ and D⁺ in
Carbon Velvet and W – Coated
Carbon Velvet**

HAPL Meeting-PPPL

December 13th, 2006

**Fusion Technology Institute
University of Wisconsin-Madison**

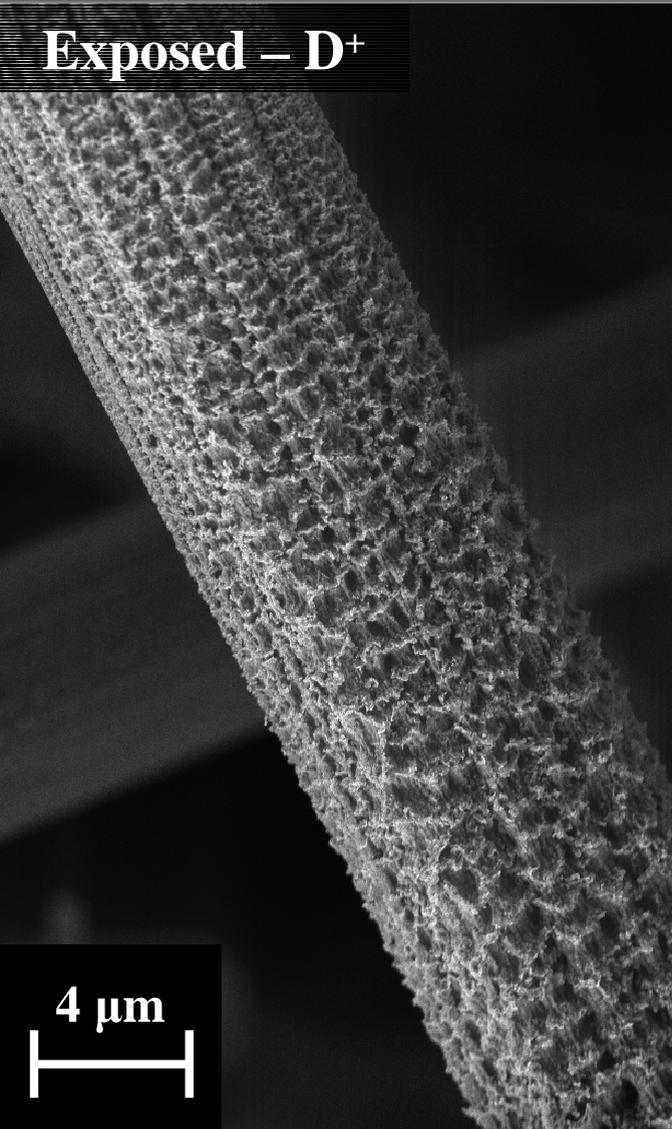
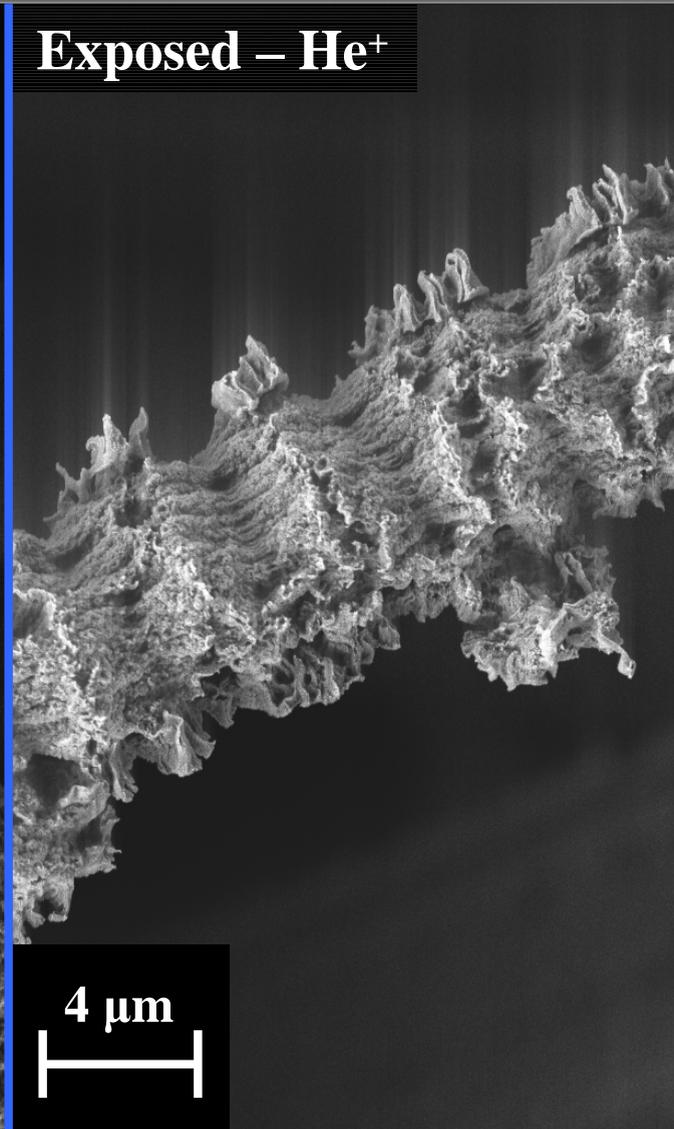
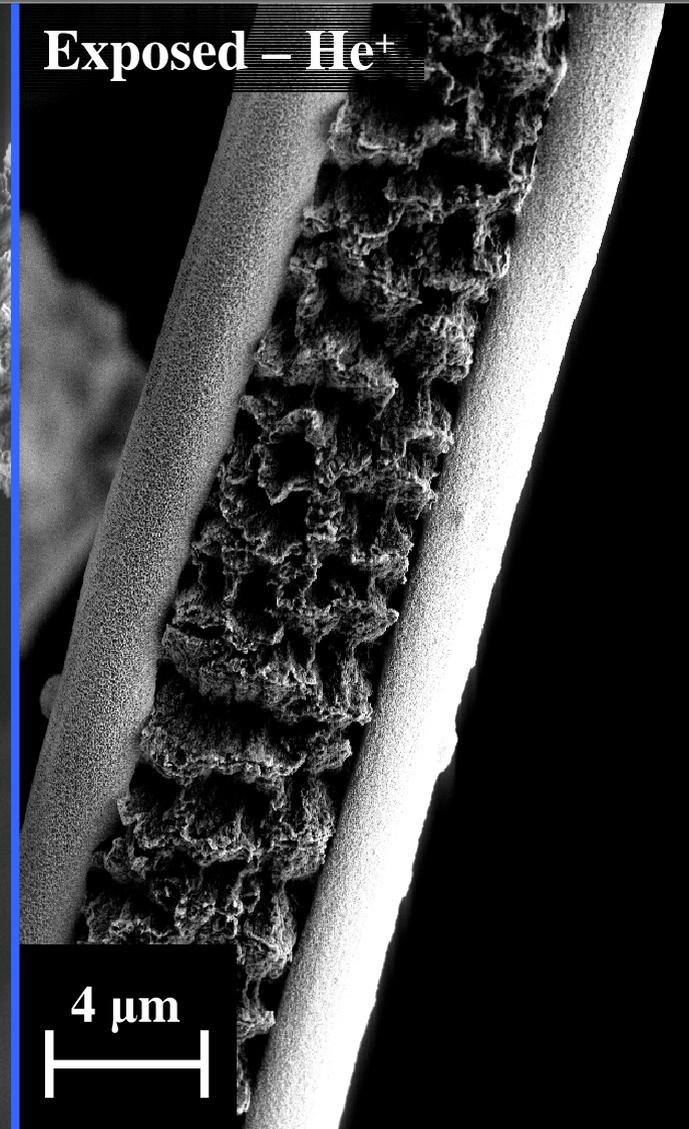
Velvet Specimens Exposed to He^+ Appear to Sustain an Exaggerated Surface Corrugation Effect

CCV – $10^{19} \text{D}^+/\text{cm}^2$ @ 1150°C

CCV – $10^{19} \text{He}^+/\text{cm}^2$ @ 1150°C

W/CCV – $10^{19} \text{He}^+/\text{cm}^2$ @ 1150°C

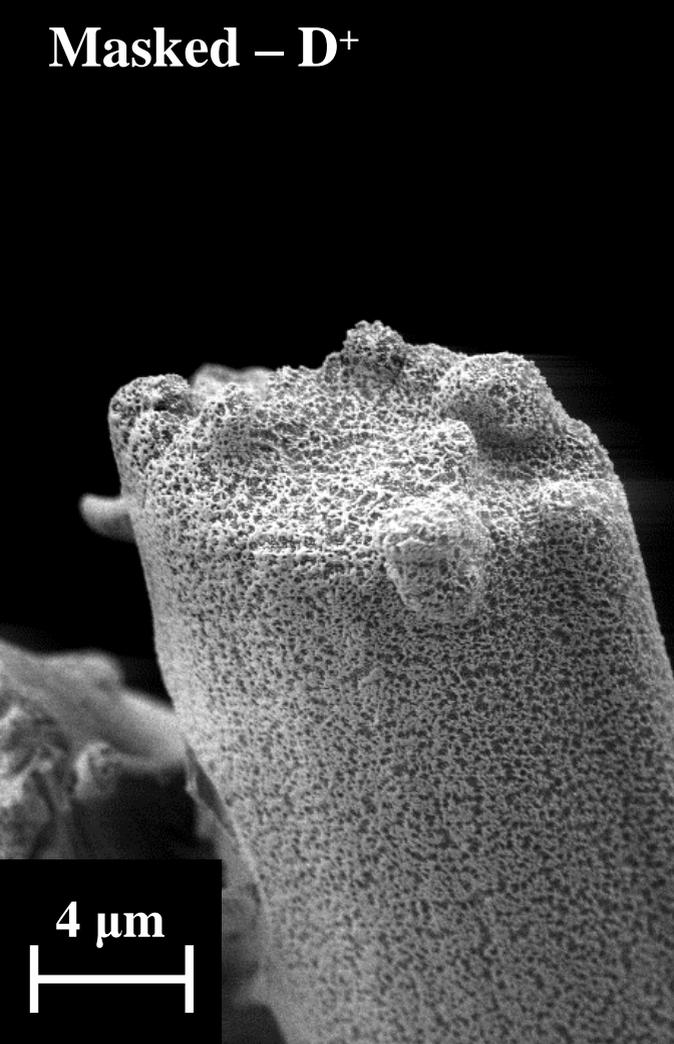
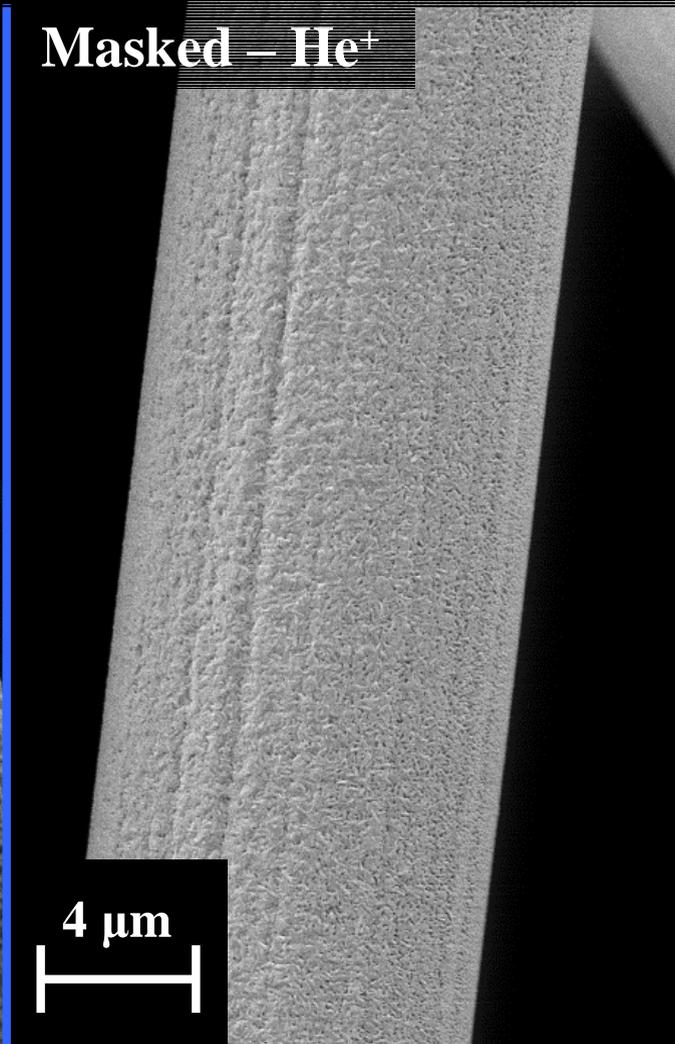
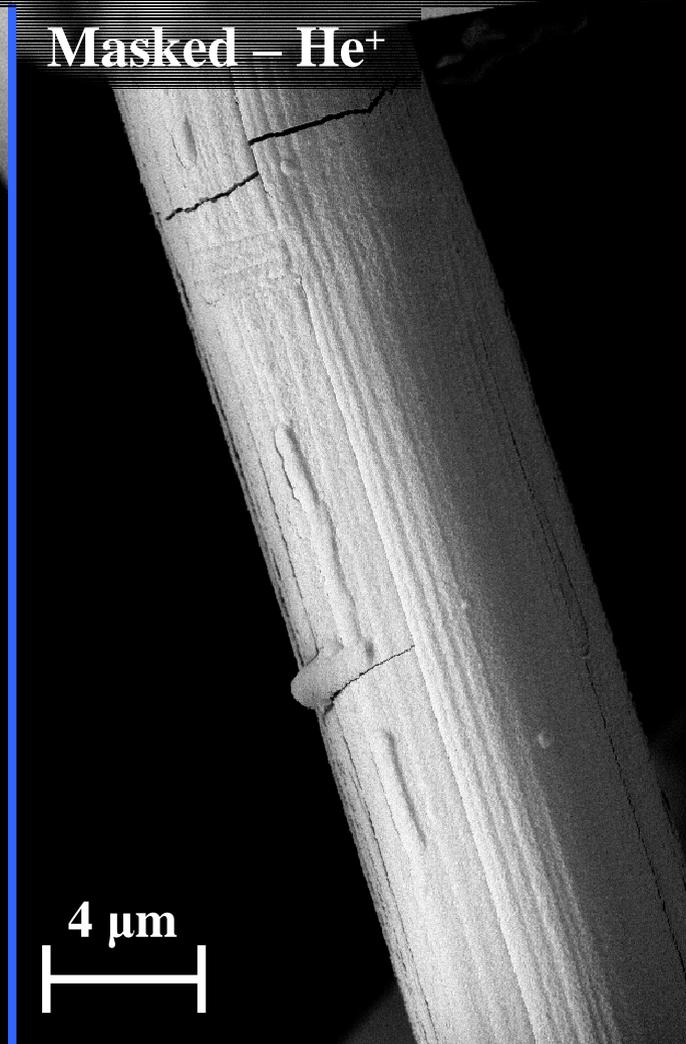
Velvet Fibers in the Masked Regions Experience Surface Pitting and W-Coating Cracks

0.5 mTorr, 30 kV, 1150 °C

CCV – 108 min. runtime

CCV – 87 min. runtime

W/CCV – 105 min. runtime

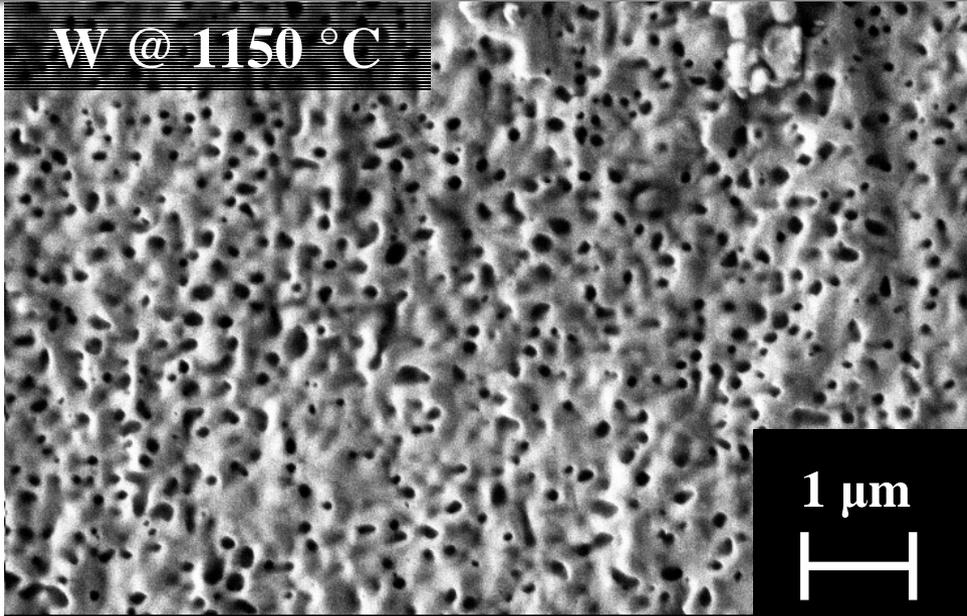
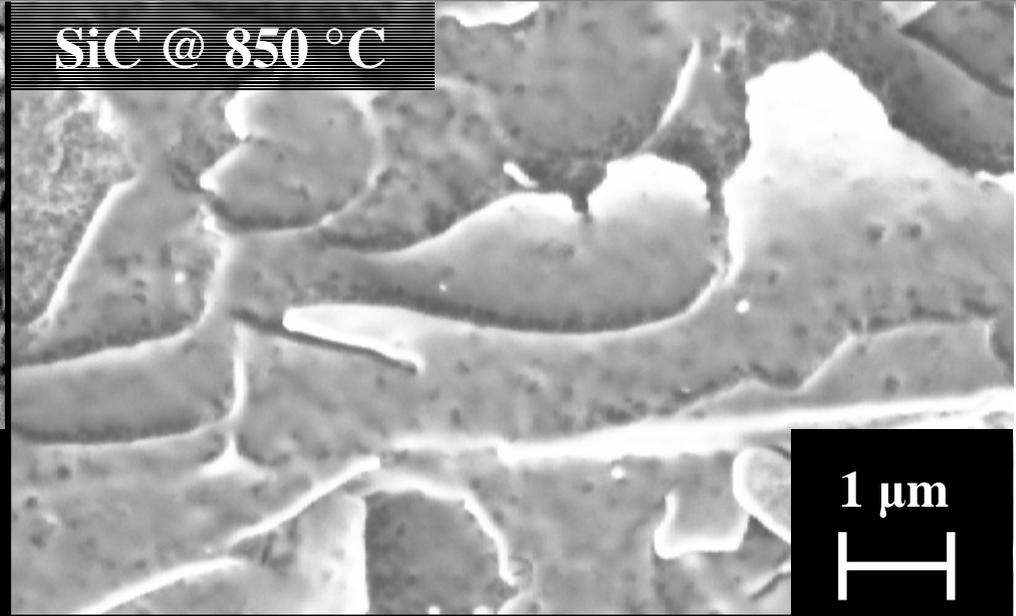
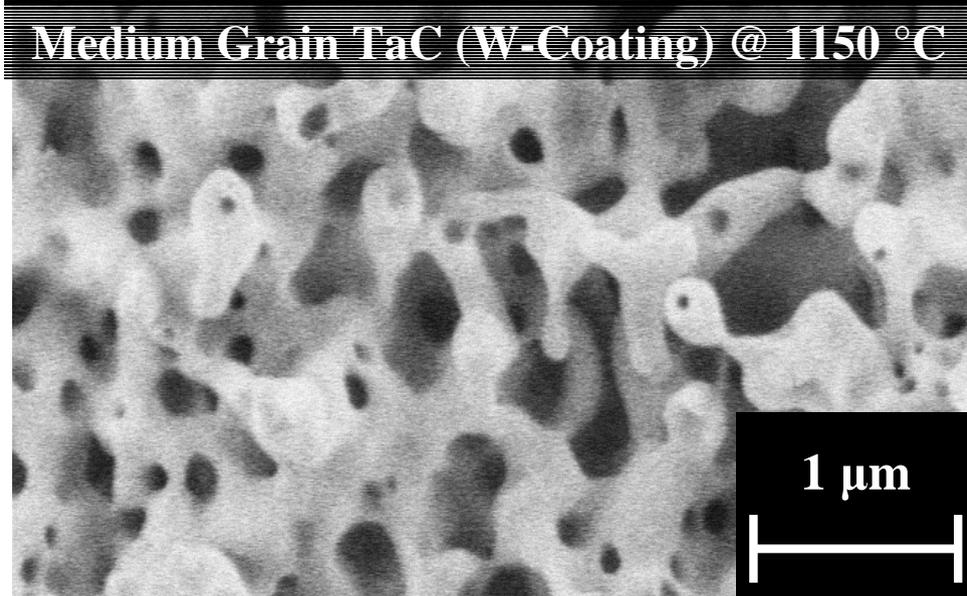
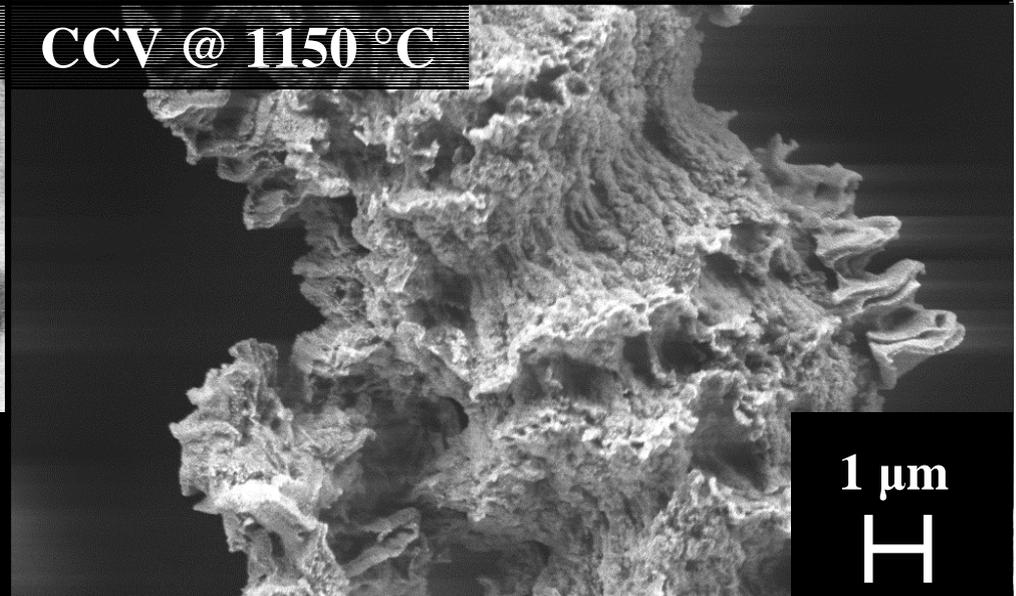
Surface Damage Comparison of W, TaC Foam, SiC, and CCV Samples at 1×10^{19} He⁺/cm²

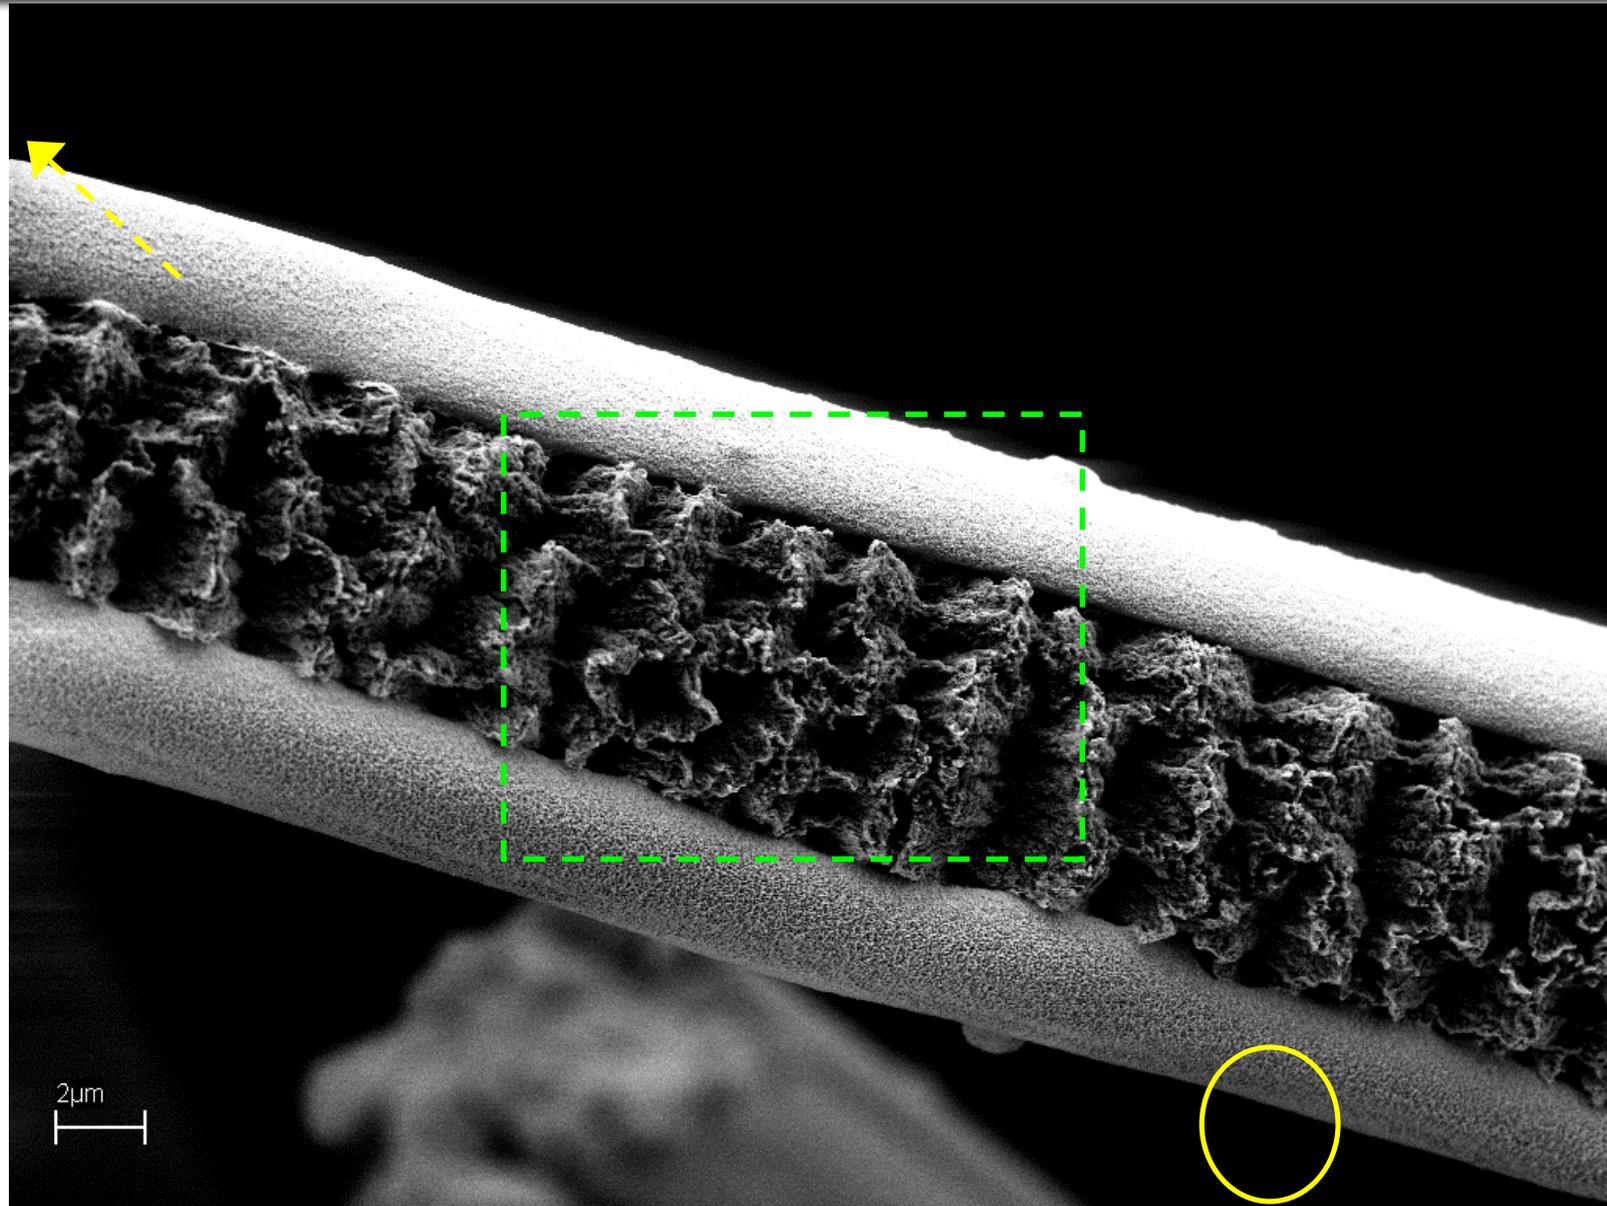
W-Coating Rupturing Occurs on Different Fibers Over the Sample

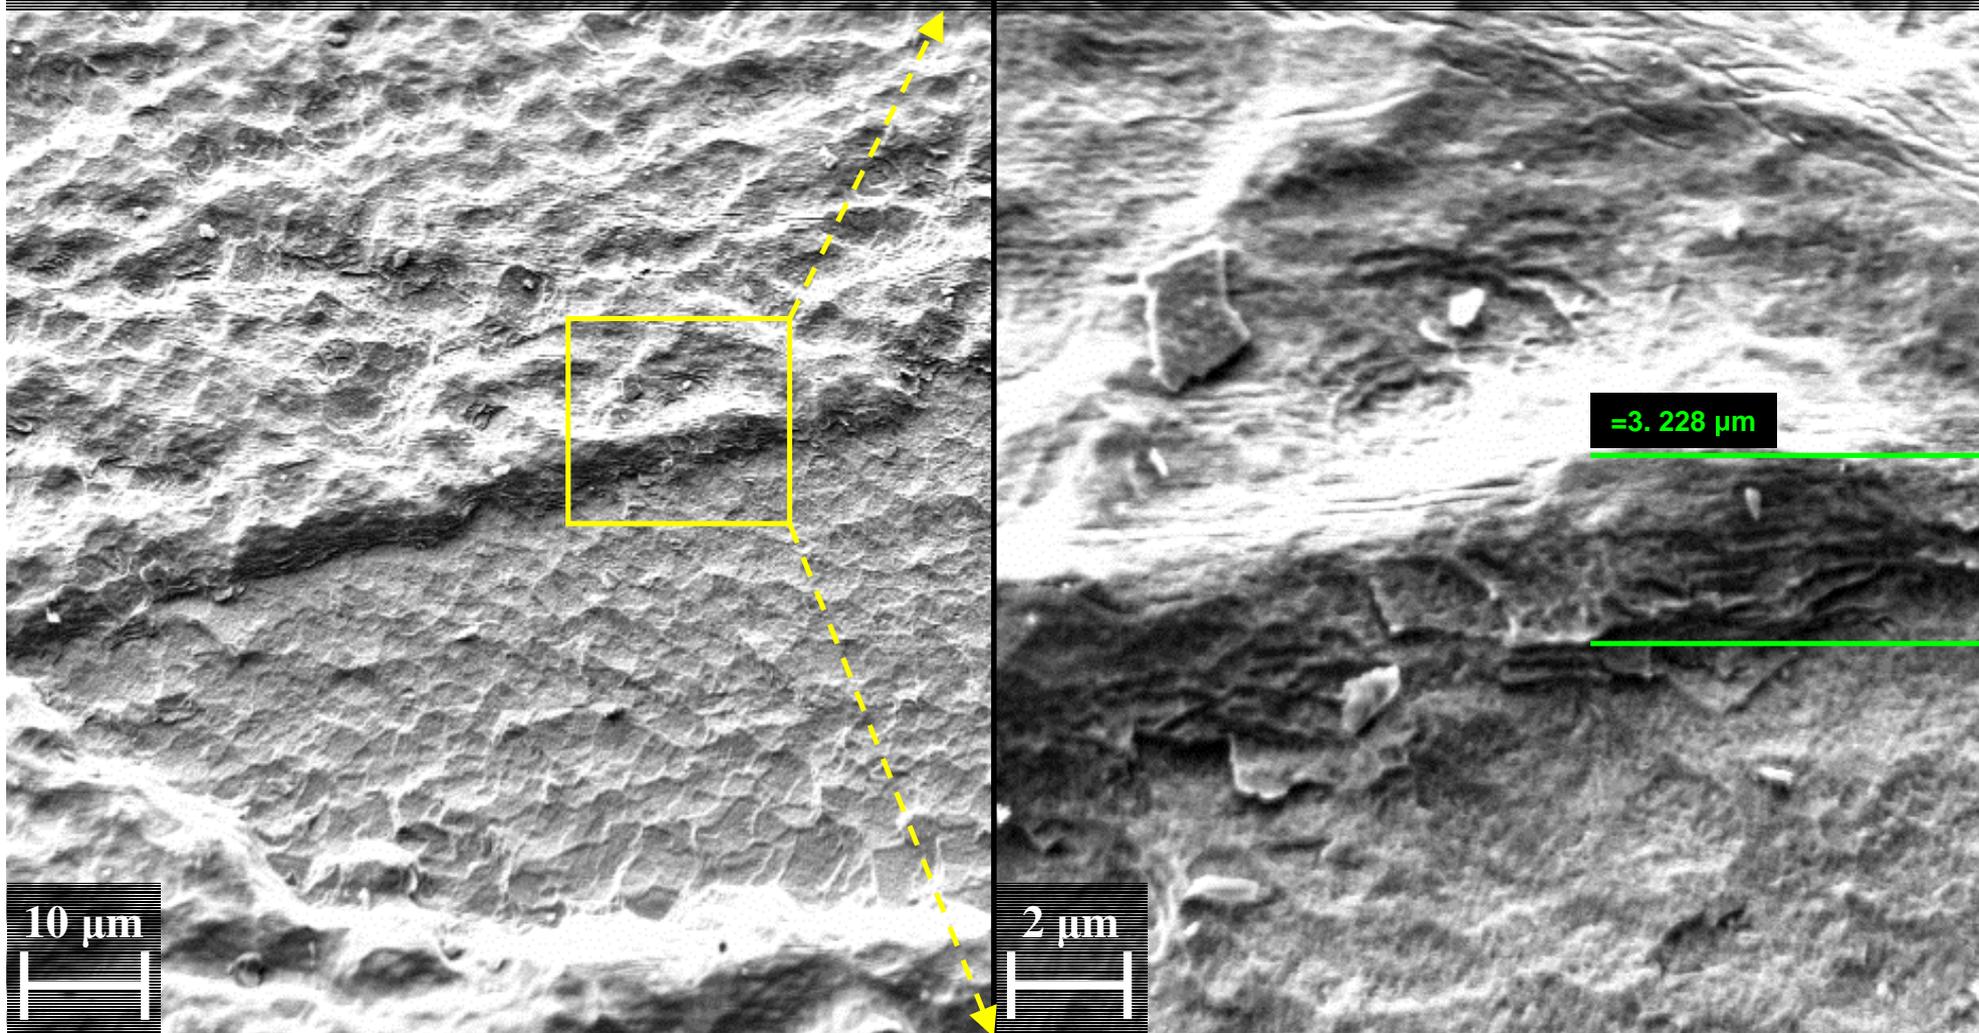
Irradiated Zone of *Masked* SiC Sample Illustrates the Effects of Repeated Flaking

Sample Tilted 35° in SEM Stage

30 kV, 5.5 mA, 950°C, $\sim 1.5 \times 10^{19}$ He⁺/cm², 147 minute runtime

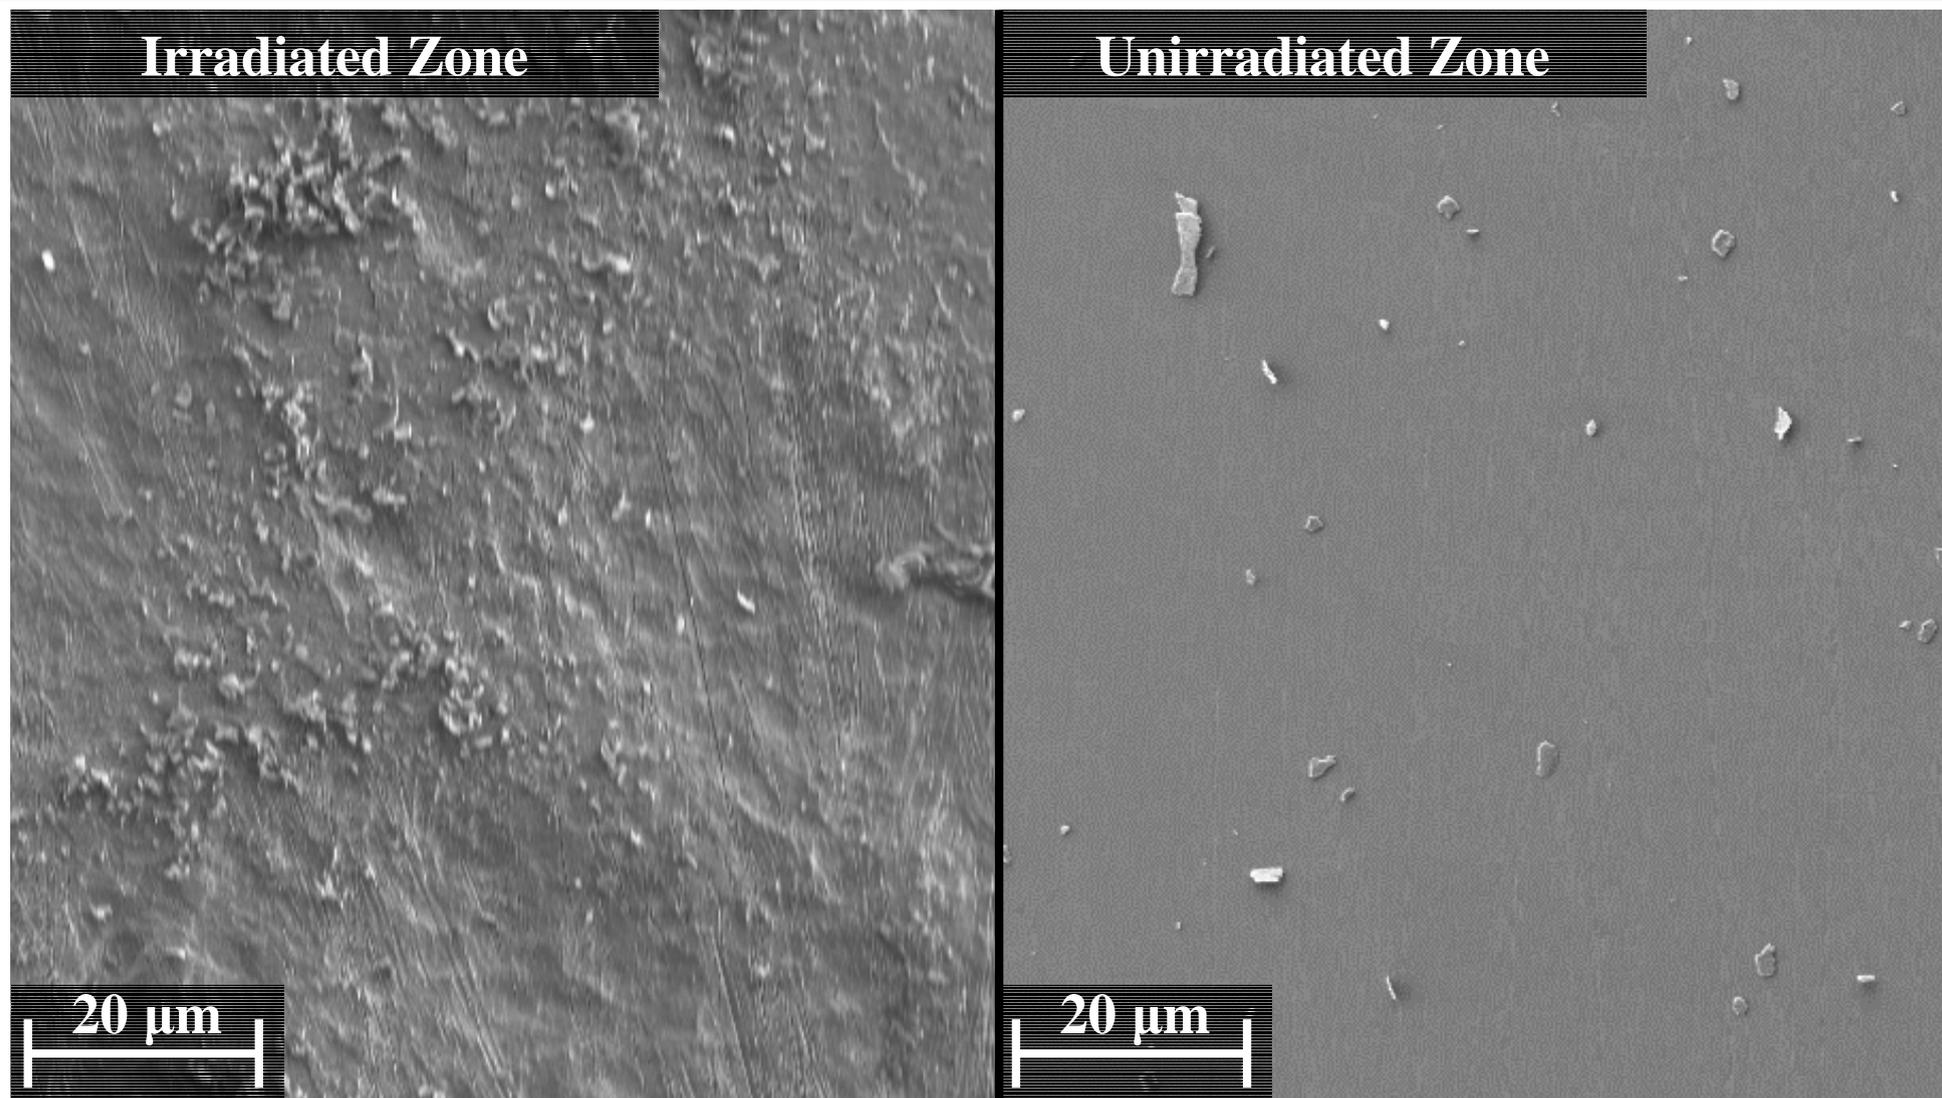
Masked SiC Sample Surface Roughening is Due to Irradiation Not Temperature Exposure

30 kV, 5.5 mA, 950°C, $\sim 1.5 \times 10^{19}$ He⁺/cm², 147 minute runtime

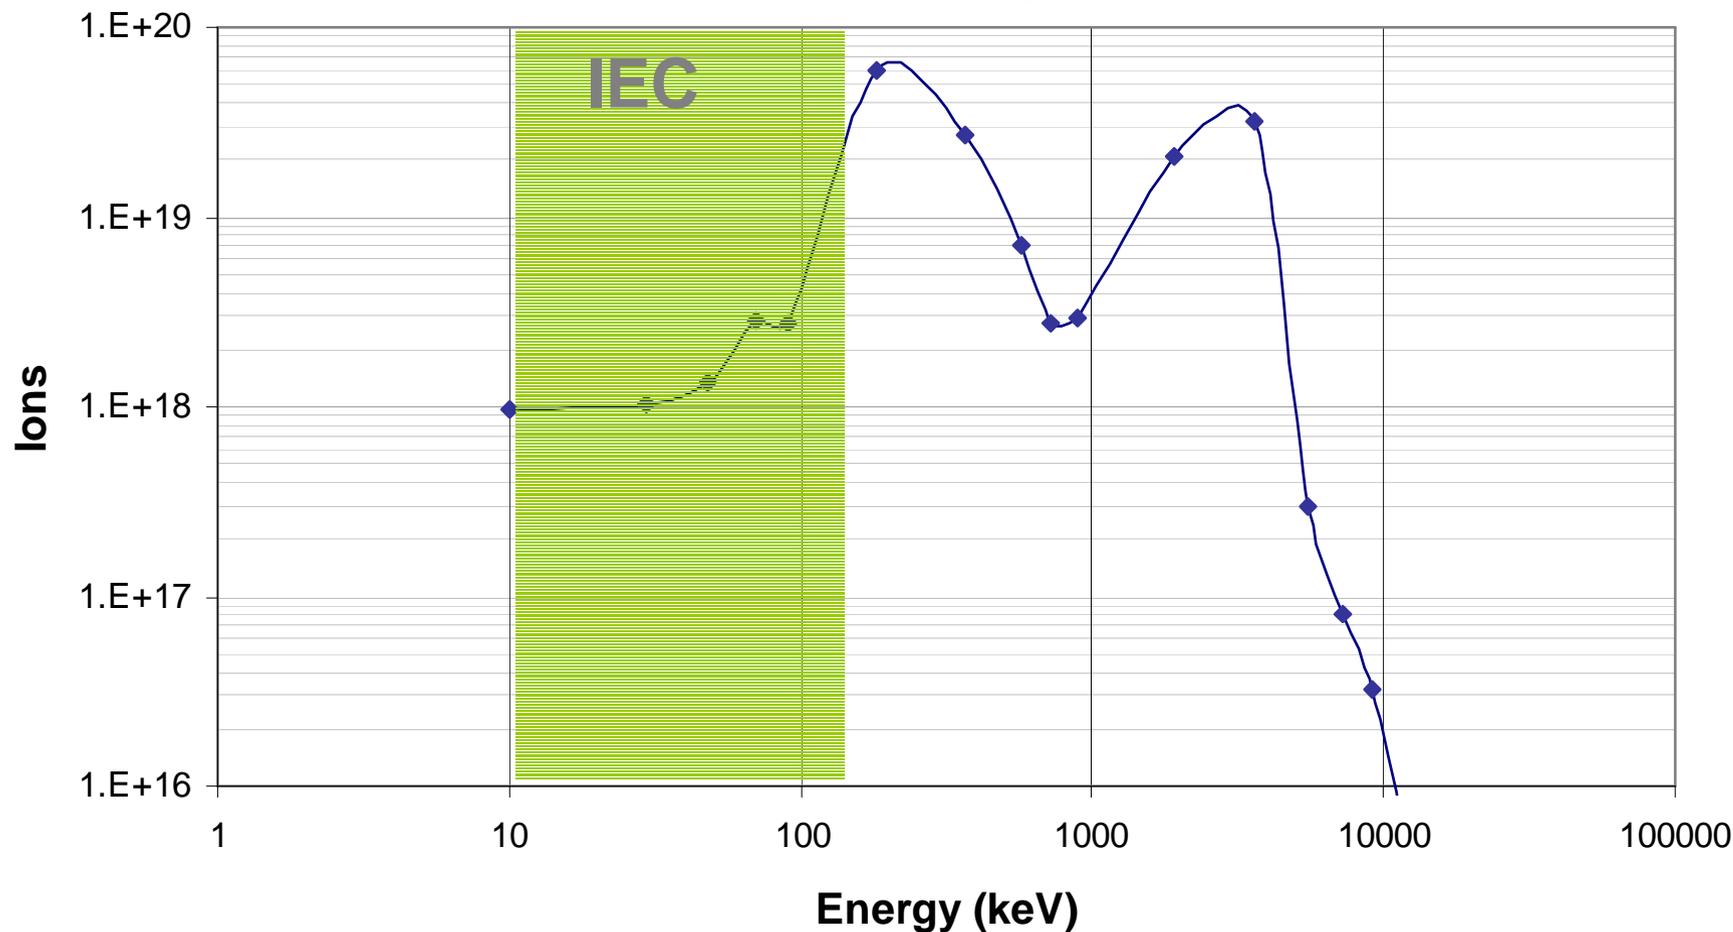
The IEC Voltage Capability Covers Nearly 25% of the Ions at the First Wall

Helium Ion Energy Vacuum Spectra

365 MJ HAPL Target

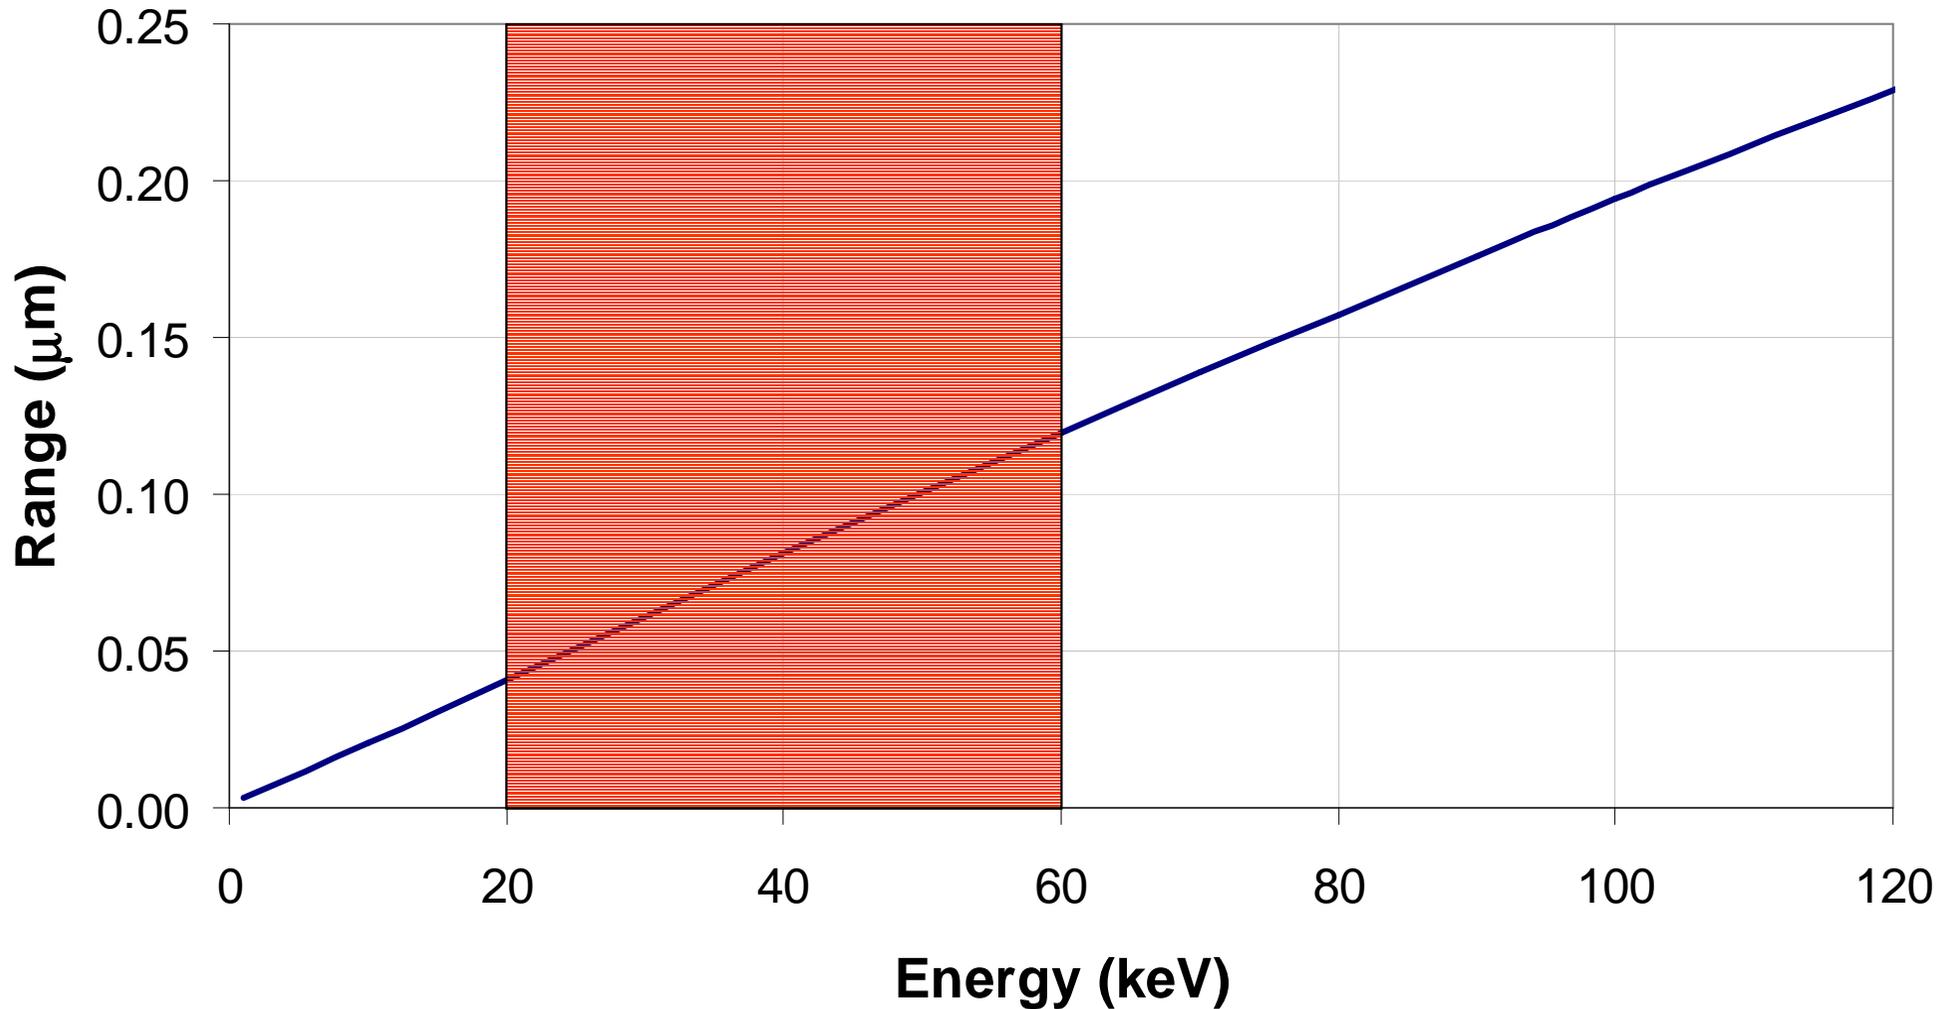
Implantation Covered a Small Range of the Helium Energy Spectrum

Range of Helium Ions in Tungsten

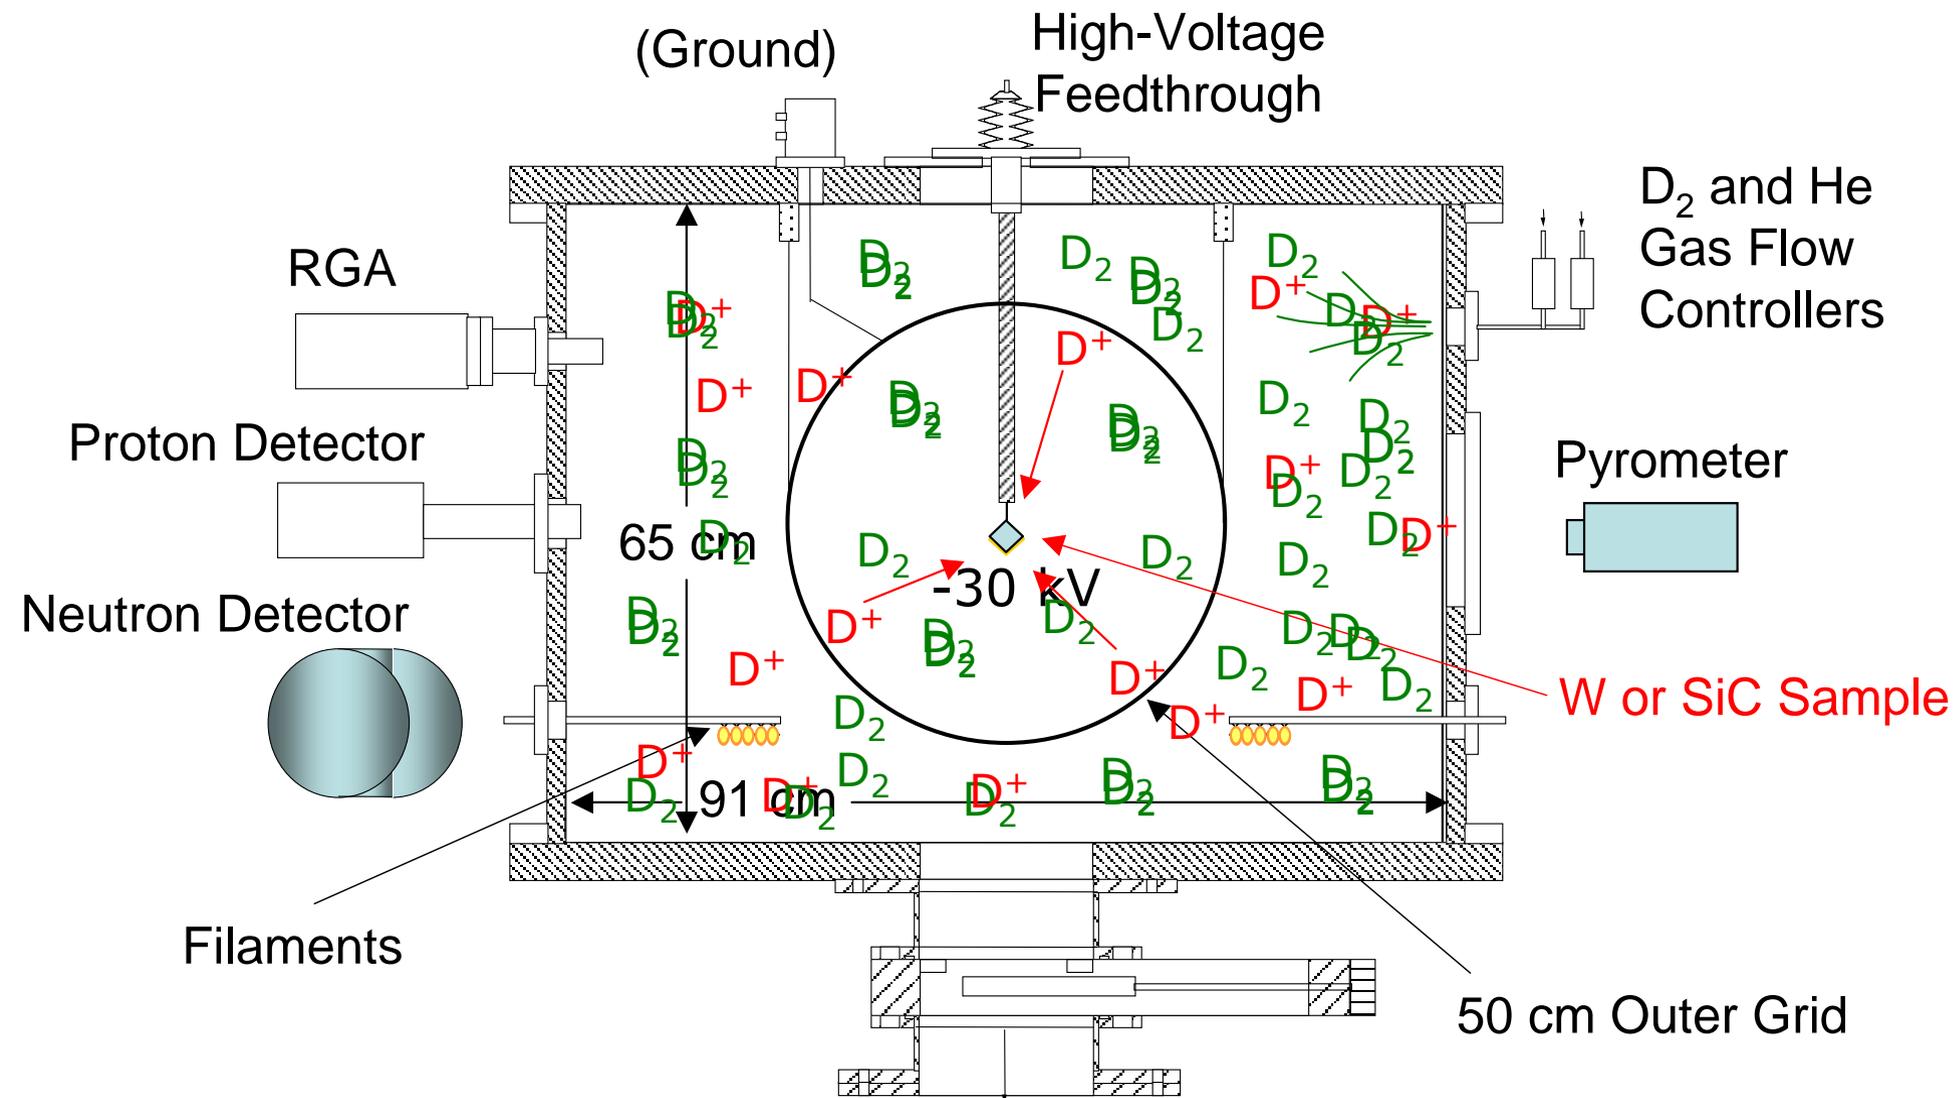
IEC Ion Implantation Process
