FIG. 3.10. Estimated world distribution of fuel failure causes.

## Detection of Fuel Failures

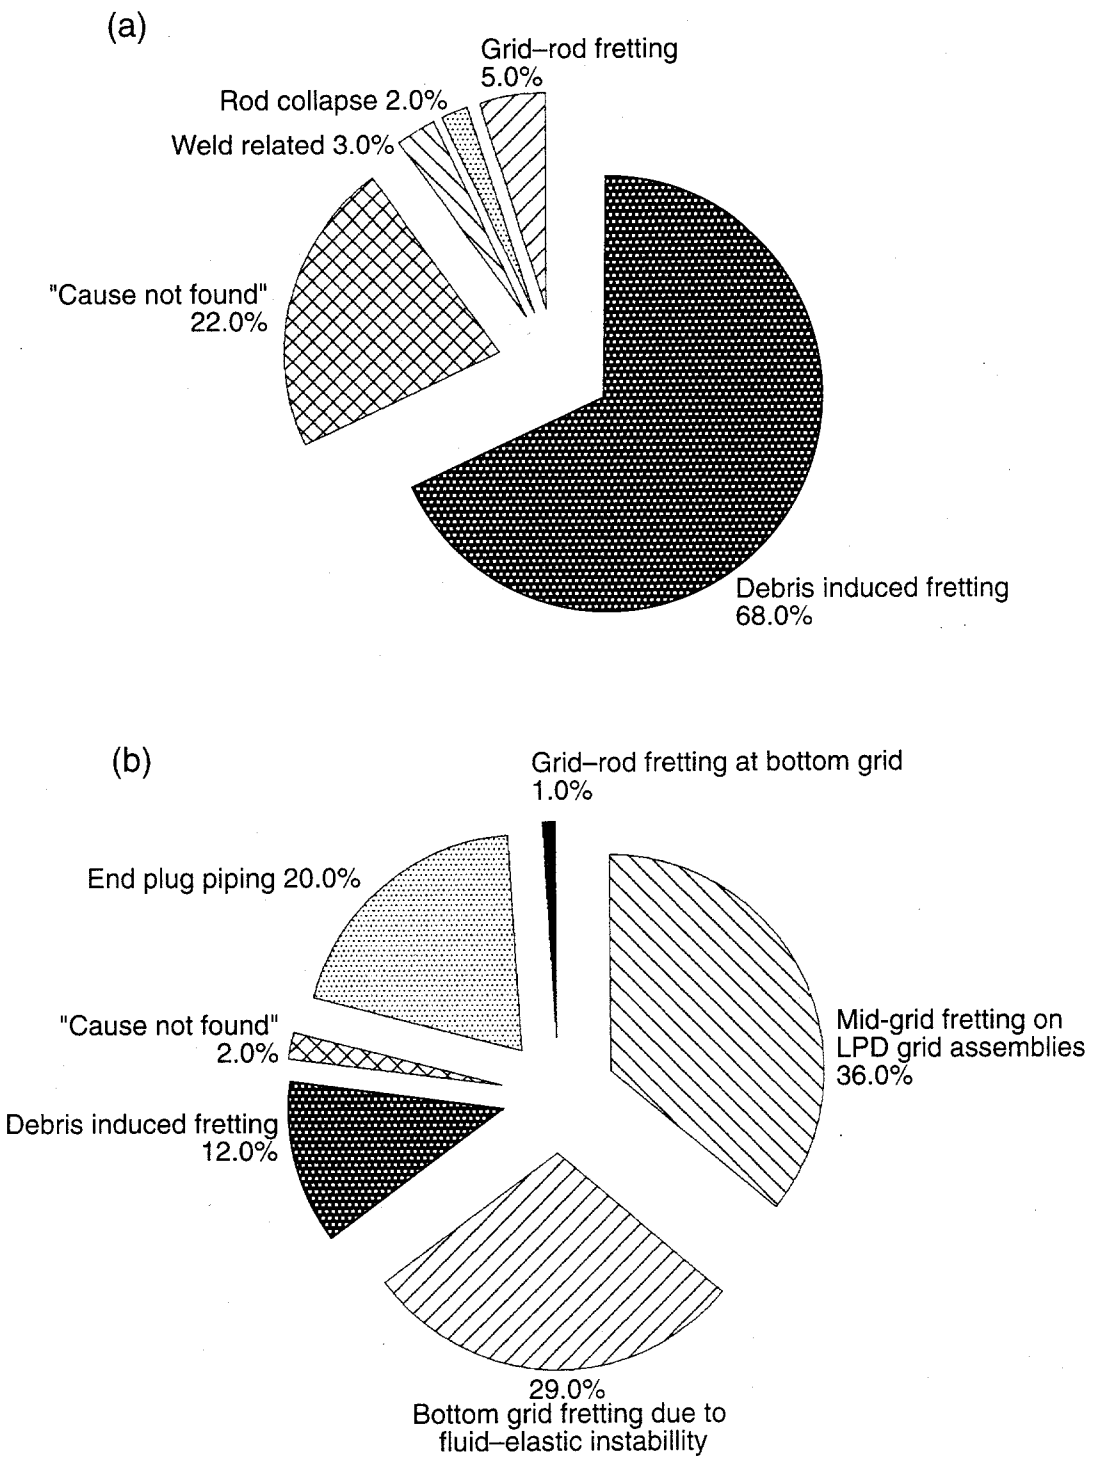
FIG. 3.8. Leakage mechanisms identified for Westinghouse fuel [3.2, 3.19]. (a) Fuel fabricated after 1983; (b) fuel fabricated after 1987.

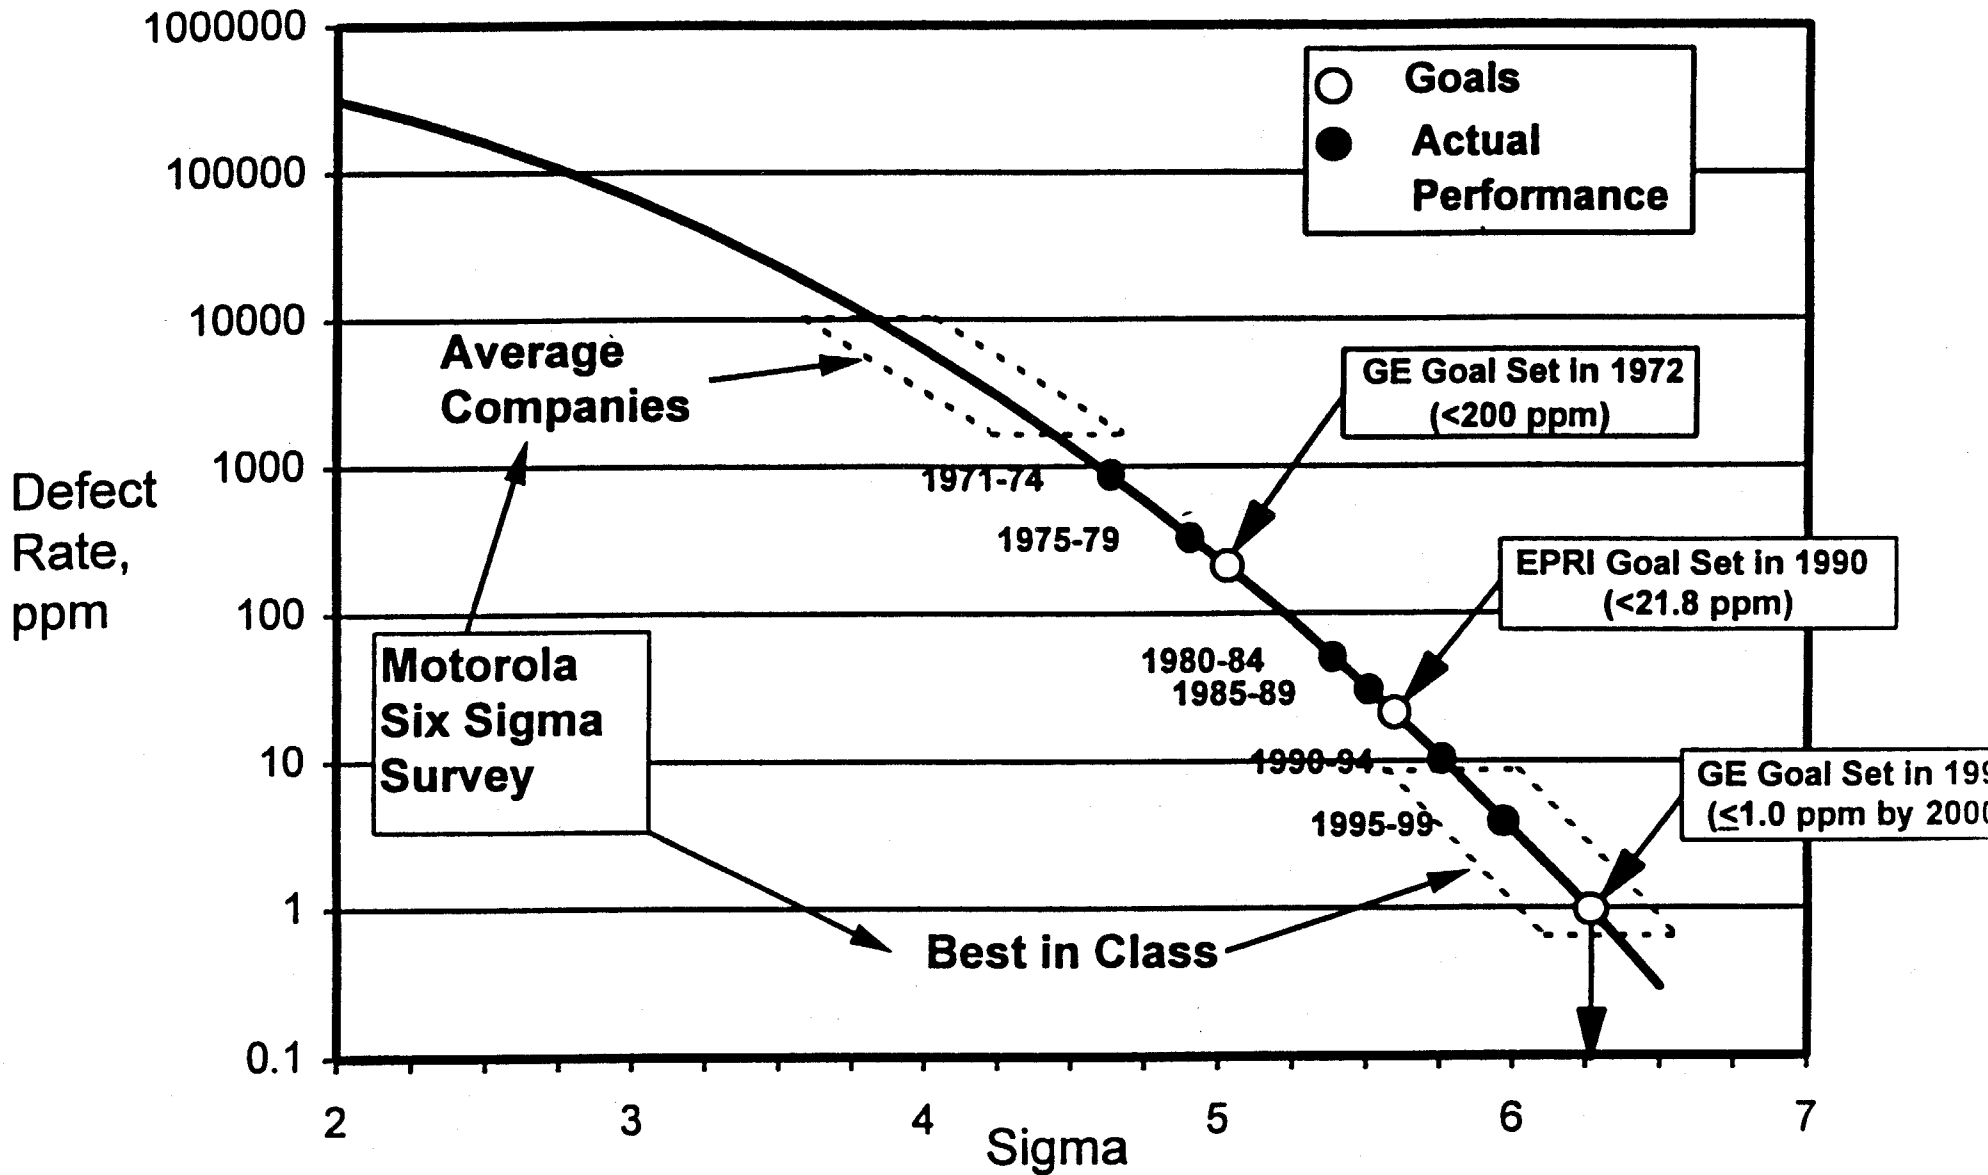
**Figure 1**  
**GE Fuel Performance Experience**

$\mu\text{Ci I-131/gm, Median Value}$

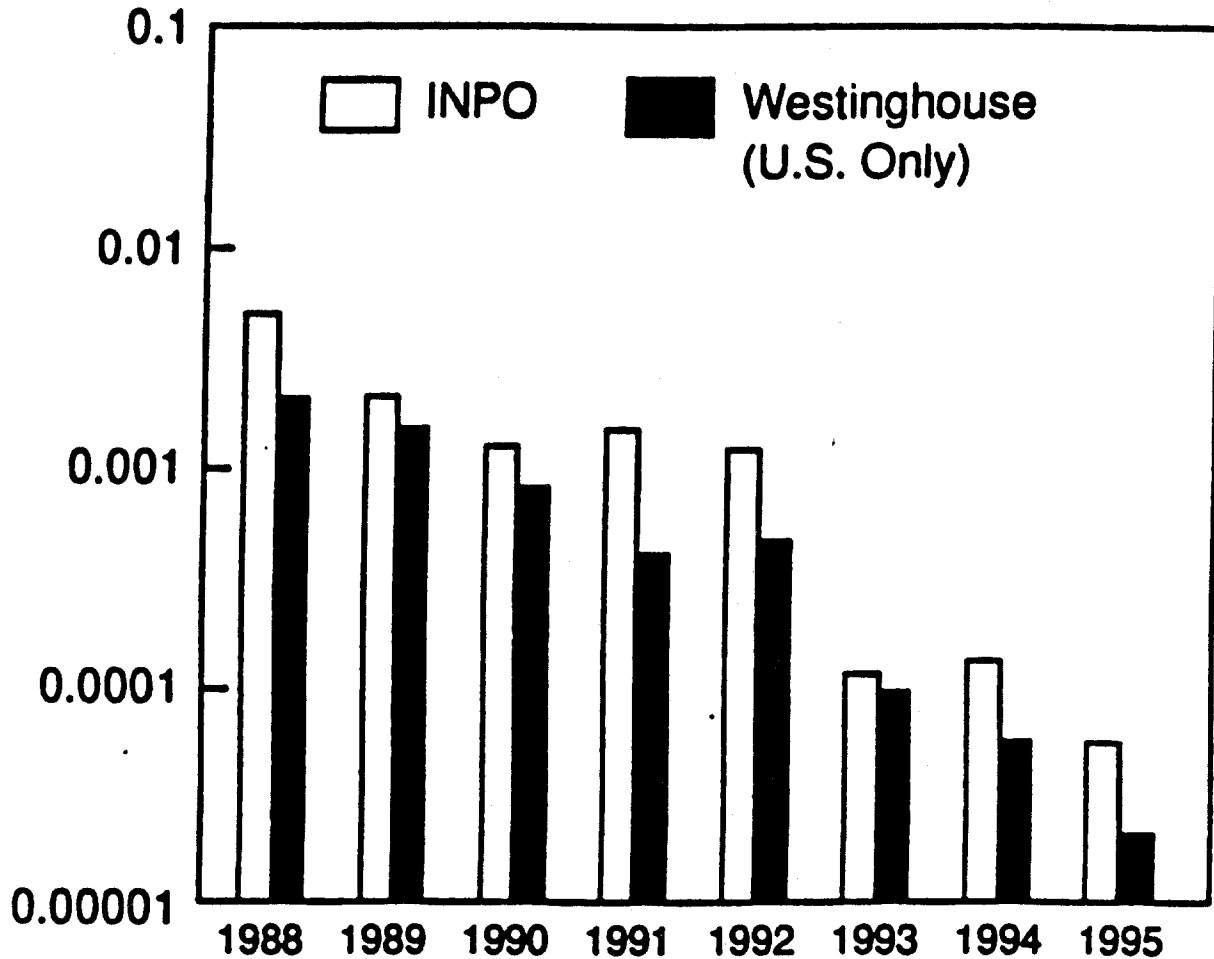
Figure 2: Westinghouse fuel reliability compared to industry averages.
